Inspection report and landslide reinstatement sign off

Project No.	P.23.1016	Date	25 September 2023
Project Name	Collins Cap Quarry Landslip		
Inspected	28/07/2023	Inspected By	FG
Client	Alltas Engineering		pitt&sherry

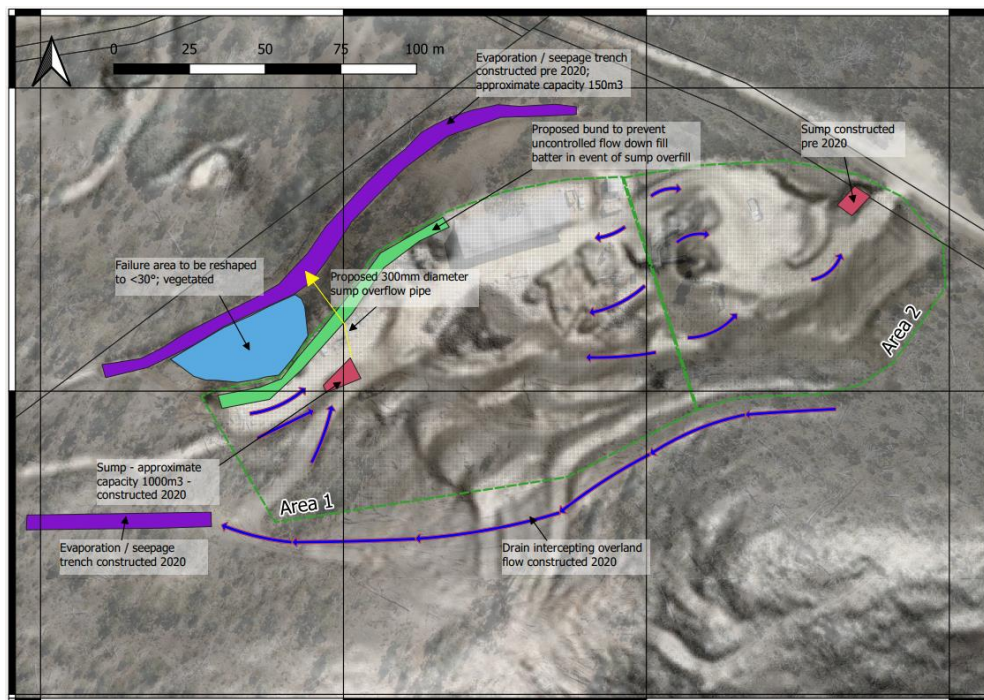
Figure 1 - recommended remediation works

- Reinstatement, reshape and revegetate the failed slope (< 30° angle, compacted to optimum moisture and maximum density)
- Reinstatement northern evaporation ditch
- Installation of overflow pipe; and
- Bund construction.

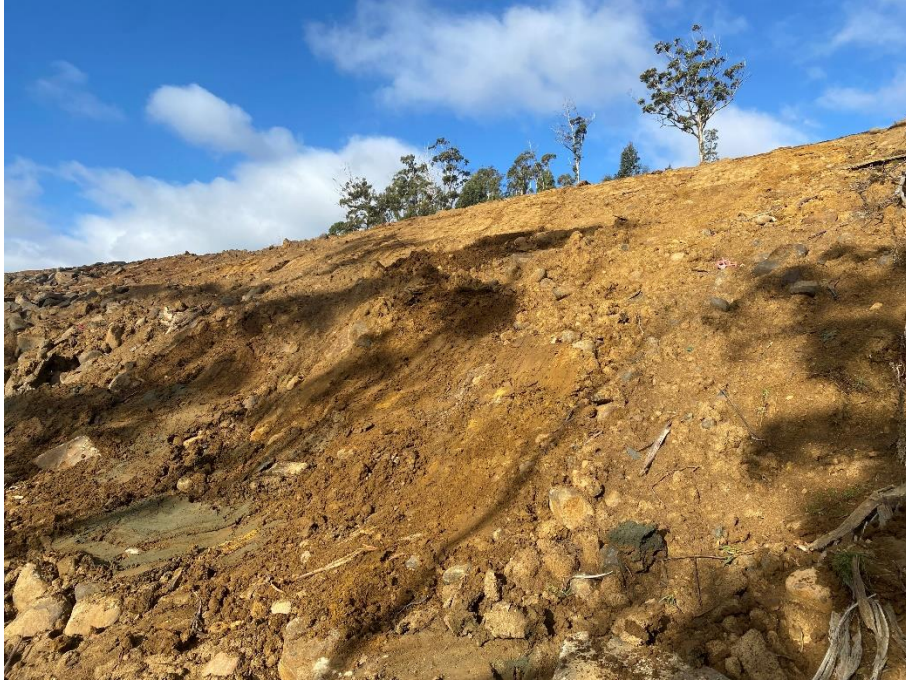
Figure 2 - landslide area reinstatement

The slope has been reinstated by filling up the concave areas predominantly with cobbles and boulders and gaps filled with soil. The backfill has been compacted using the bucket of the excavator present on site. The areas downhill from the landslide have been reinstated to their original condition prior the landslide occurred, including the evaporation ditch.

The slope has been reinstated to an angle steeper than recommended. Revegetation has been attempted by the quarry managers, however the abundant wildlife present in the area has not allowed it to establish.

Despite the fact that the recommended slope angle has not been achieved it is assessed that the addition of the large blocks and the interlocking nature of these has achieved the intended level of stability. It is unfortunate that the vegetation has not established due to the high numbers of native animals in the area, but again, as the stability has been achieved through the use of interlocking larger blocks, the necessity for stabilisation through root growth is reduced.

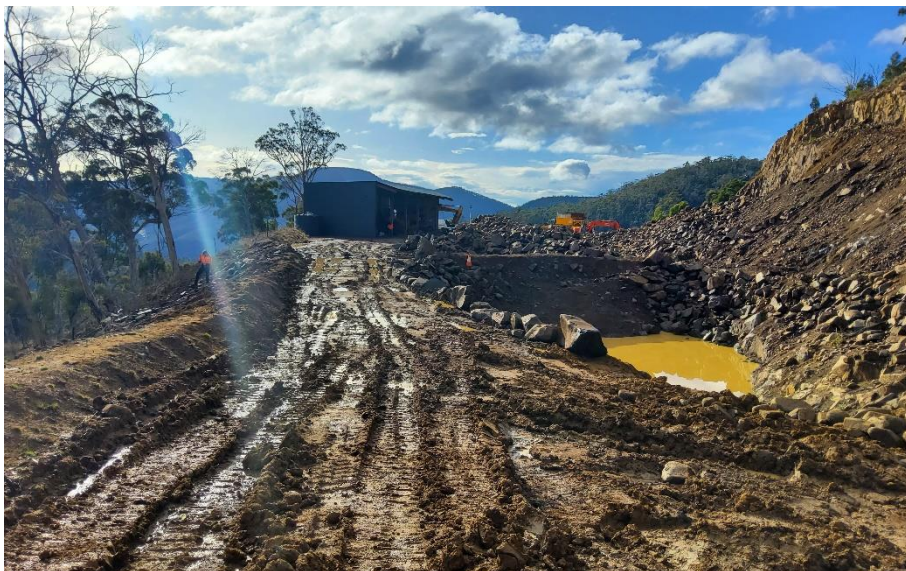
Figure 3 - bund on the left hand side

A bund approximately 1m wide and 0.8 to 1m high has been built above the landslide scarp to reduce the potential of any possible sump overflow entering the landslide area.

Figure 3 shows the internal track that sits above the 2021 landslide. It has been recommended to the quarry managers during the inspection that the track is shaped so that water drains into the sump and that a gravel layer is added in order to avoid machinery creating depressions and to maintain the road shape.
