FIELD DEPLOYMENT REPORT

EAGLE MONITORING SOLUTION

The Client	UPC/AC Renewables
Project Code	UPC-001
Services	IoT Device Installation
Commencement Date	June 2020

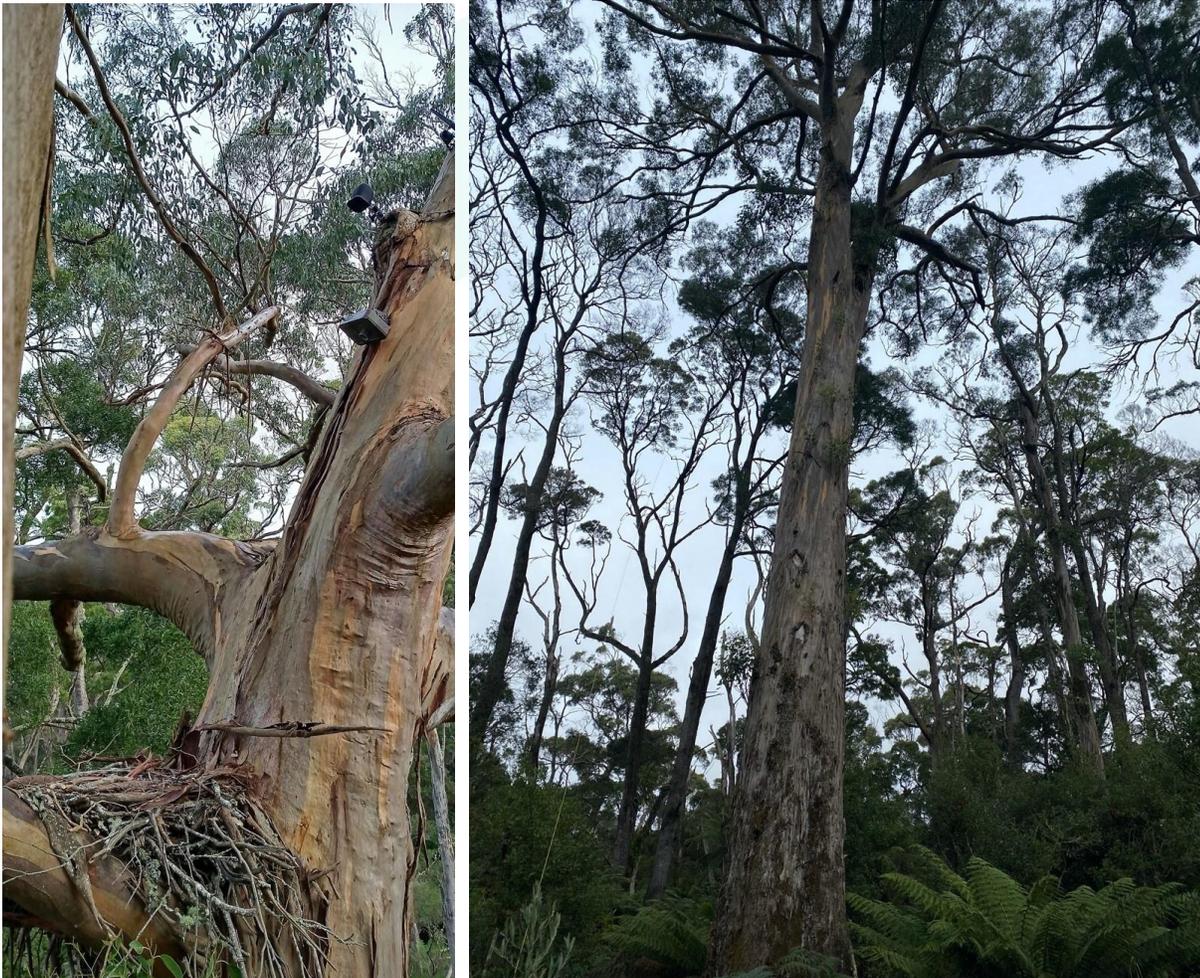
This site was located, and the nest observed, however the nest condition is noted as being very poor. Despite this, there were signs of nest usage, including dropping underneath the tree however this may not be from eagle activity.

Site was successfully installed

Figure 2 - Installation at JP1 site noting poor nest condition

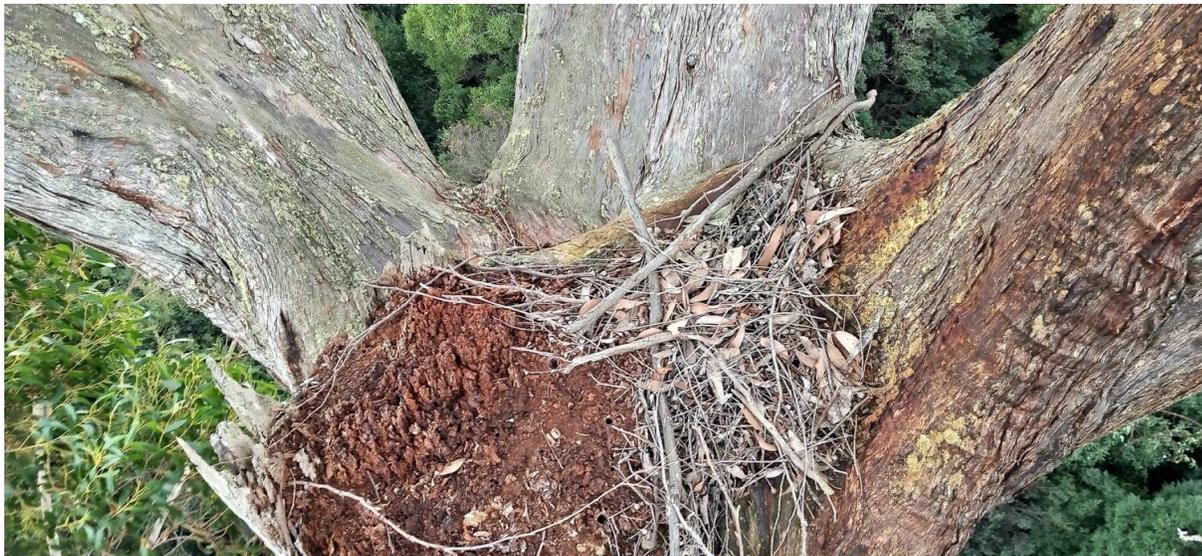
This site was observed as a possible nest location from previous aerial survey but had not been inspected from the ground. After a ground search, the nest tree was located, however there did not appear to be a viable nest from the ground. To confirm, the tree was climbed and the suspected nest was found to be substantially damaged and considered no longer a viable site for eagle use. 2 Tasmanian Wedge-Tail Eagles were cited within 150m of the candidate tree, perching in a nearby large eucalypt. A visual survey of the nearby area from both the ground and by tree

climber failed to locate the location of a nest. The weather at the time of searching was overcast with light showers, adding additional difficulty to locating a nest.

Site not complete due to insufficient data to locate nest

Figure 3 - TL5 tree showing potential past nest site

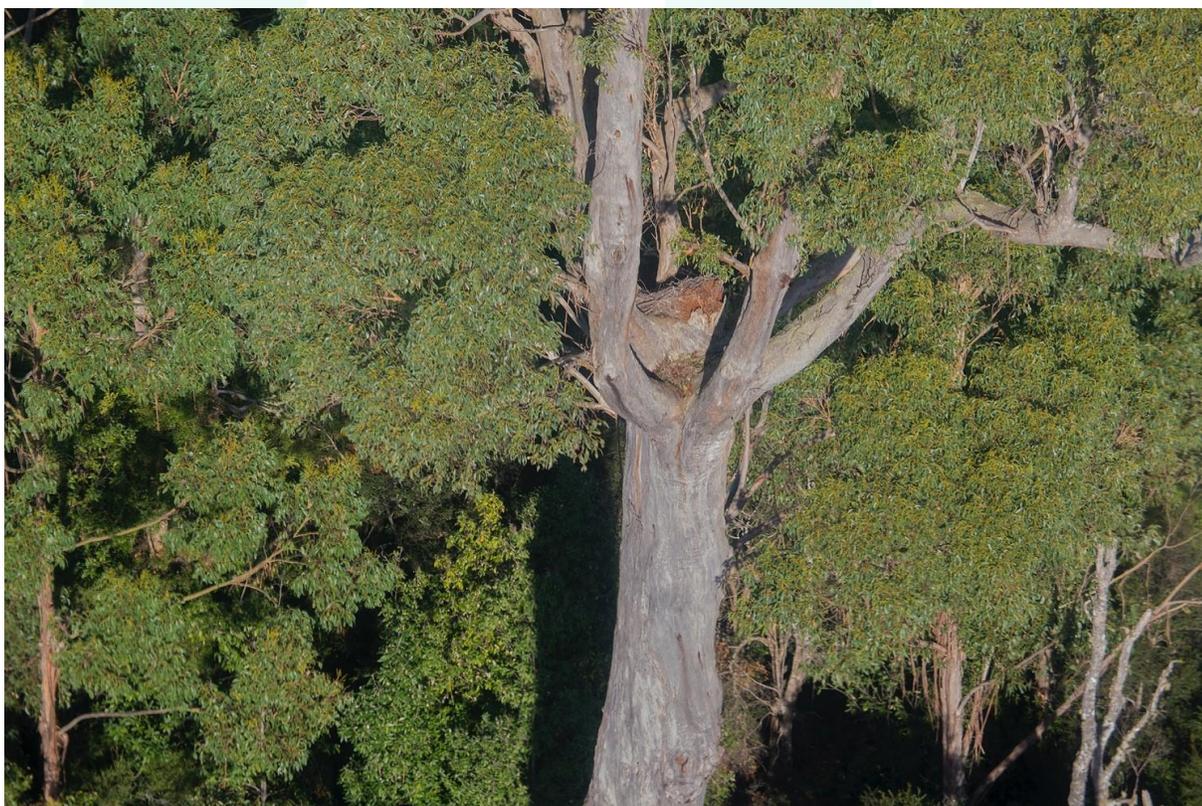
Figure 4 - TL5 site from helicopter survey (2019)

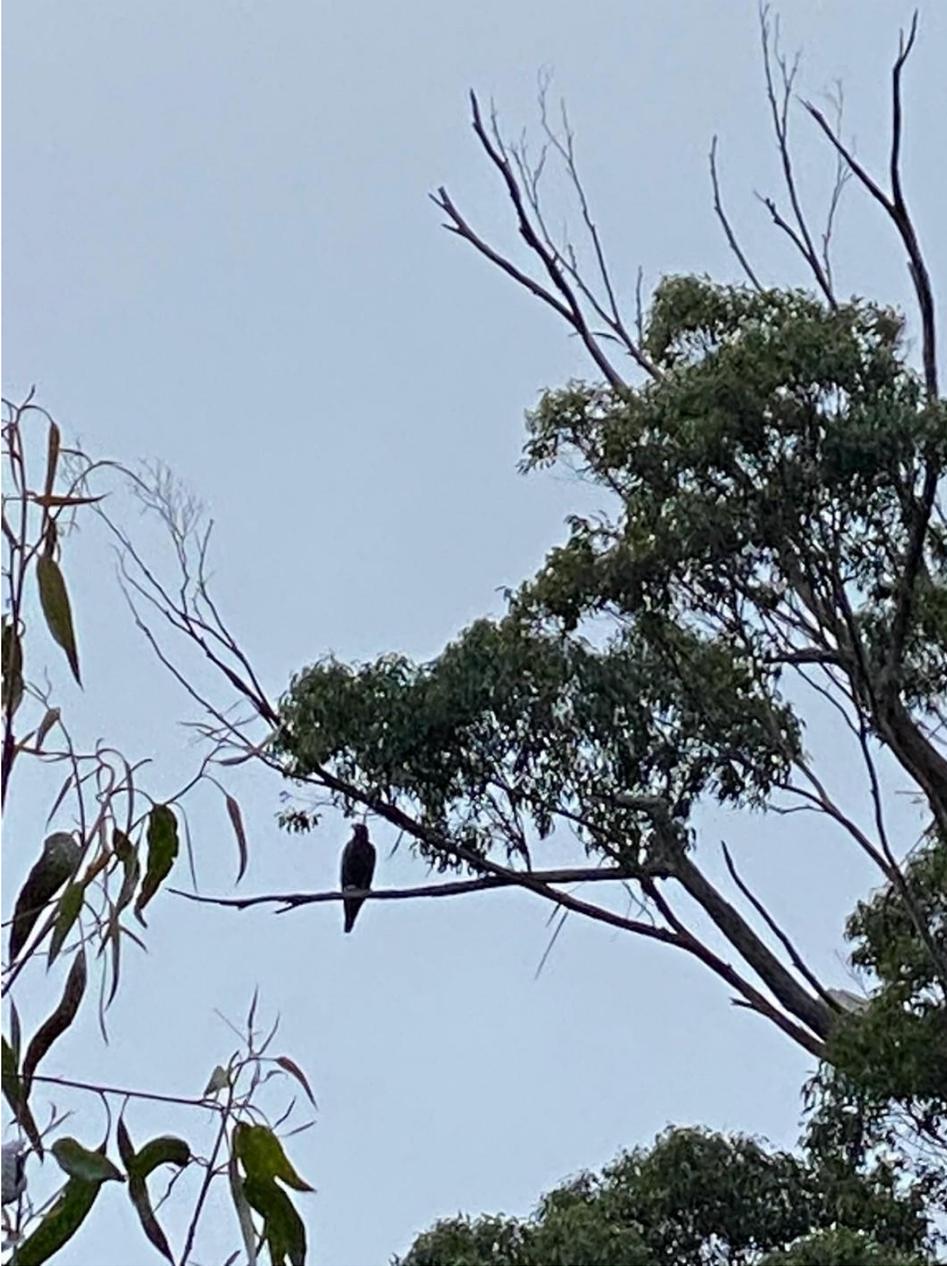
Figure 5 -Tasmanian wedge-tailed eagle cited near TL5 location

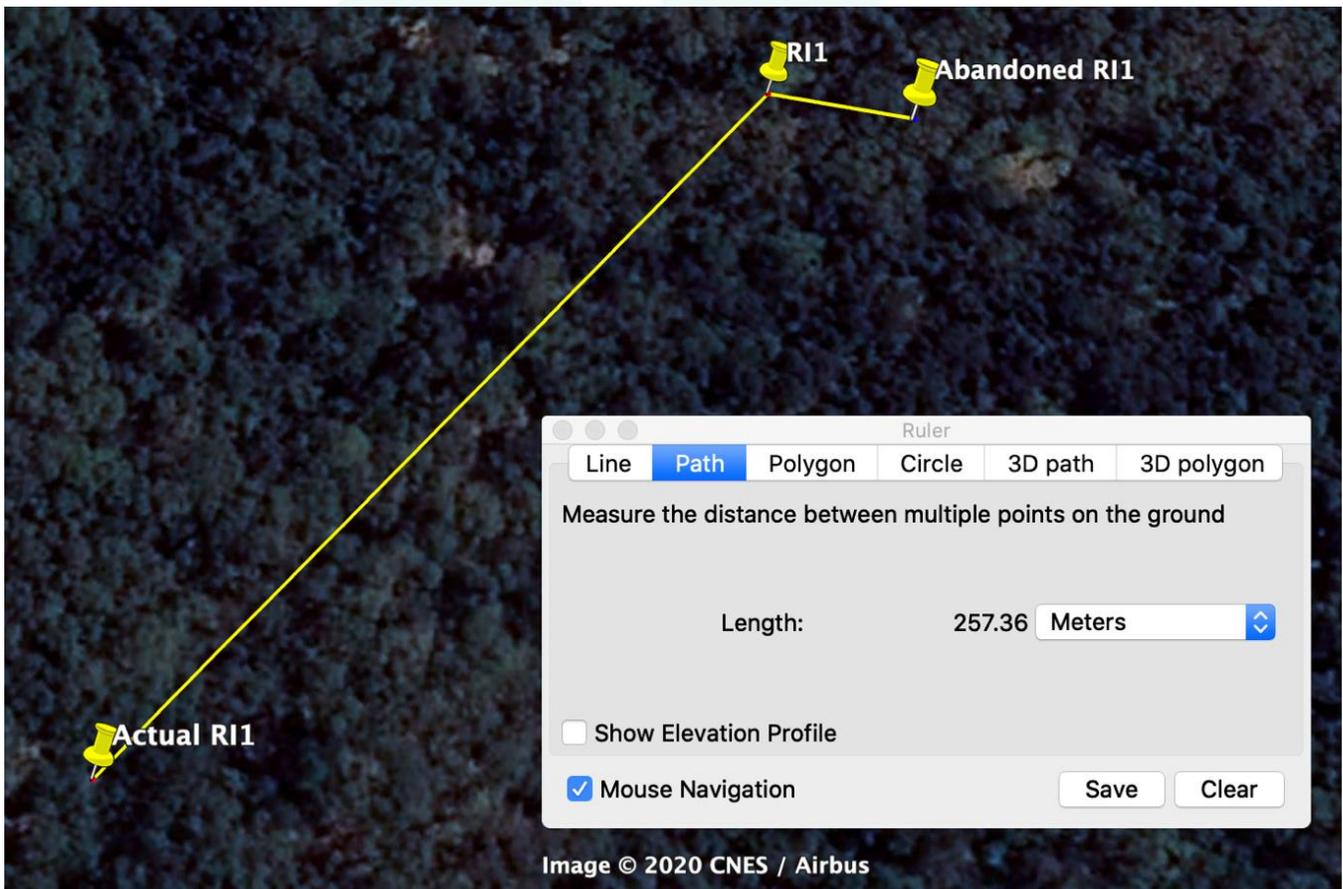
Upon arriving at the co-ordinates obtained from the Nest Survey Report, a partially collapsed nest was located within 35m of this location. It is very likely that this was the nest that was seen on that occasion. However, the nest appears to have sustained substantial damage since the survey and now appears unlikely to be in use. This nest is located at 333518.00 m E 5492708.00 m S.

The nest in better condition is located around 220m SW of the original coordinates in the Nest Survey Report. This nest is located at 333334.00 m E 5492550.00 m S.

Figure 7 - Map showing difference in RI1 nest installation

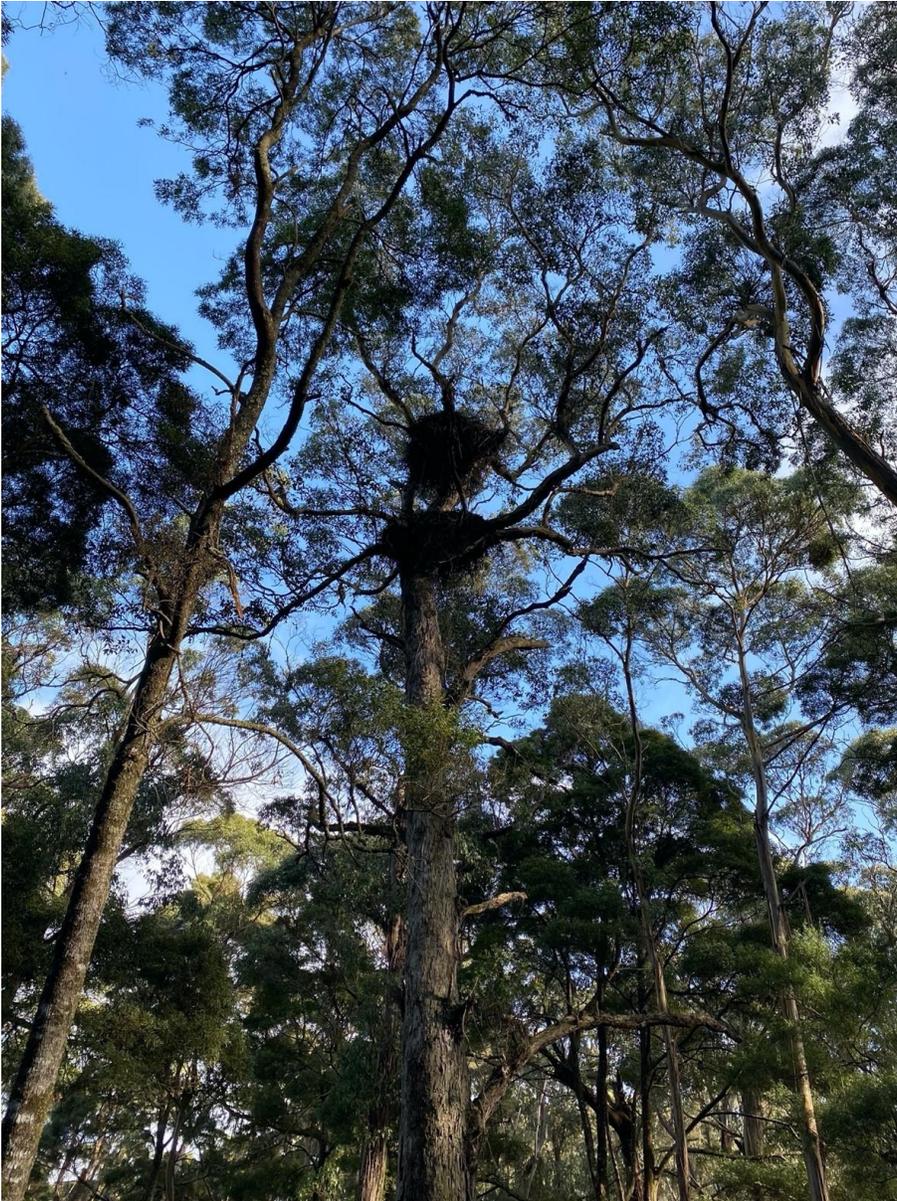
A Tasmanian wedge-tailed eagle was observed flying in very close proximity to this collapsed nest and a brief search of the area successfully located a much higher quality nest.

Given the relatively close proximity to the original location observed in 2019 and the citing of a Tasmanian wedge-tailed eagle in the area, it was agreed to install sensor and camera equipment in this alternative nest location.

Figure 8 - RI1 Nest where monitoring was installed

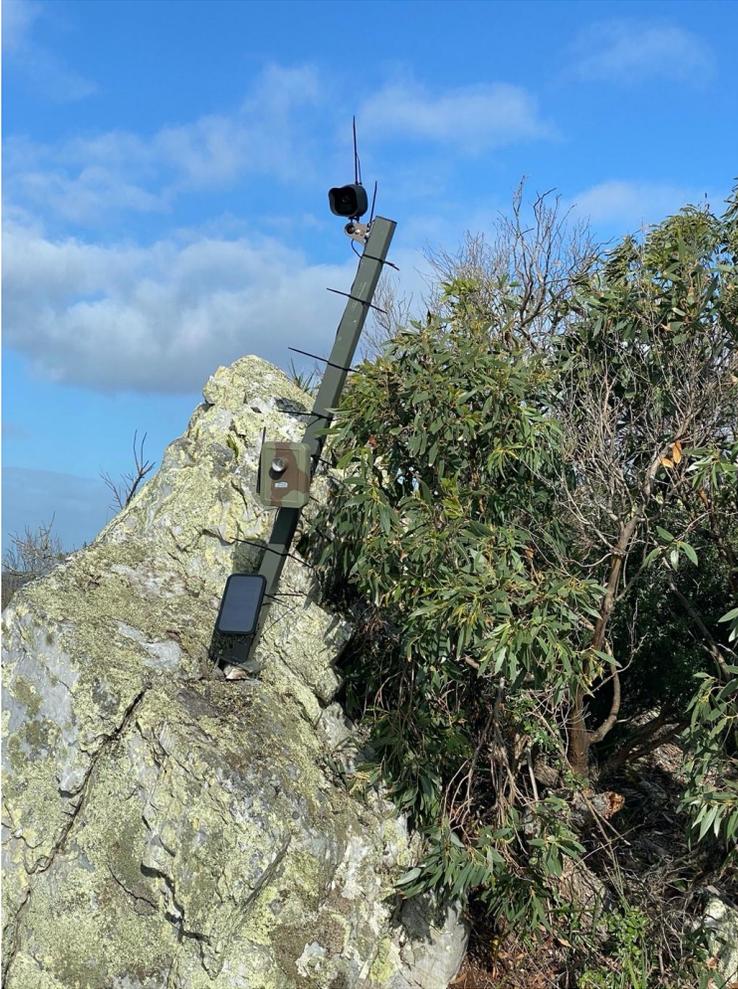
This White-bellied sea eagle nest is located on a rocky outcrop on the northern tip of Robbins Island. As there are no trees in close proximity to the nest, monitoring equipment was installed on an aluminum post bolted to the rock in a suitable proximity to the nest.

Figure 9 - Monitoring installation at RI2

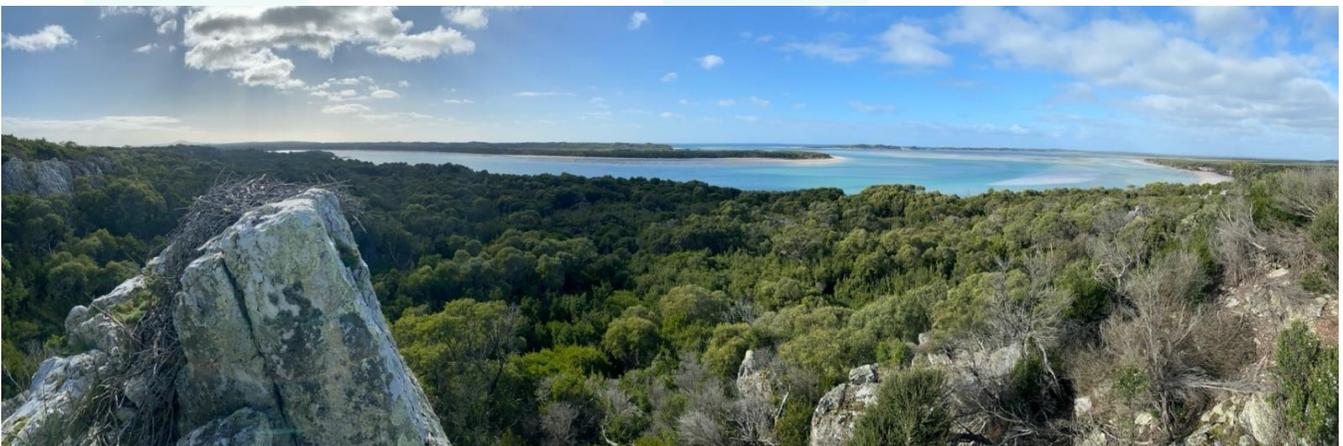
Upon arriving at the site, 2 eagles were observed in the nest and subsequently flying overhead. It is expected this will be an active nest in the short term. The nest was observed to be in excellent condition.

Figure 10 - RI2 nest site

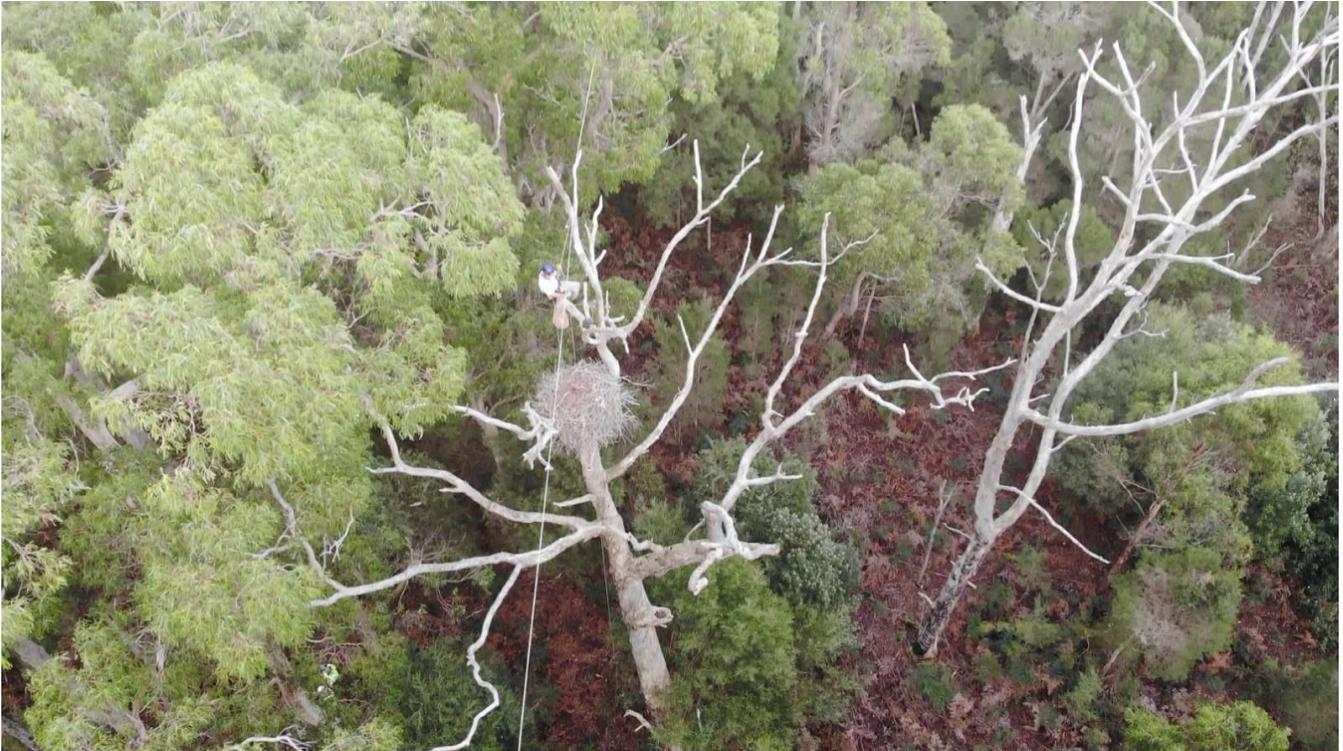
Located in a large dead eucalypt, this Tasmanian wedge-tailed eagle nest was an extremely difficult installation due to the risk of tree and limb collapse during climbing. However, by suspending ropes above the nest location, climbing was successful and monitoring equipment was able to be safely installed.

Figure 11 - Tree climber during install at RI3

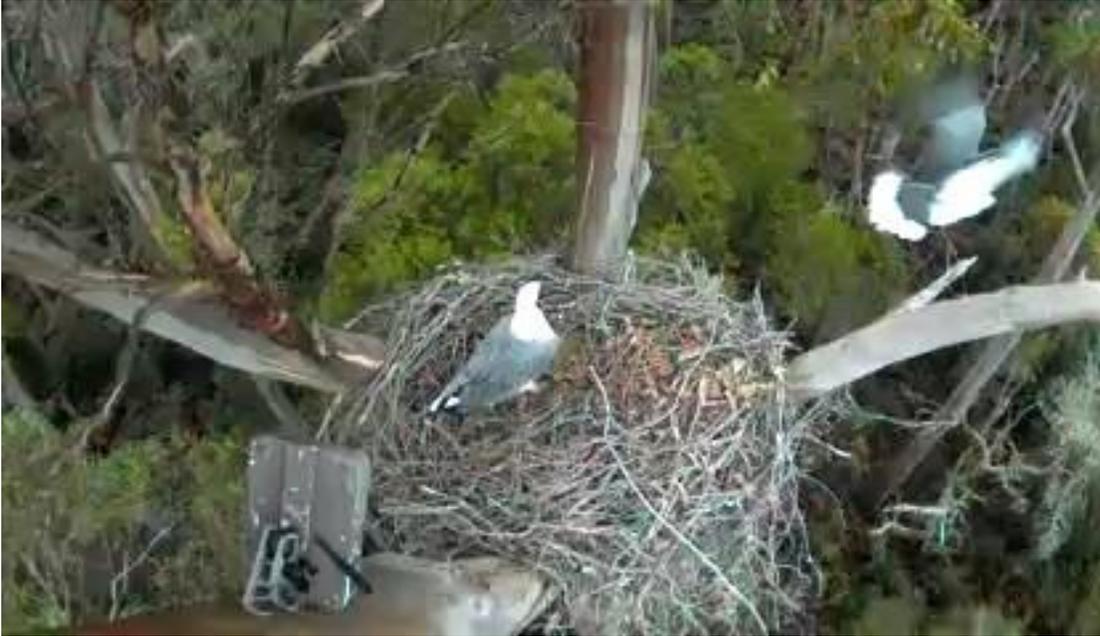
White-bellied sea eagle nest located in large eucalypt. Nest was observed to be in excellent condition.

Figure 13 - White-bellied sea eagles in RI4 nest

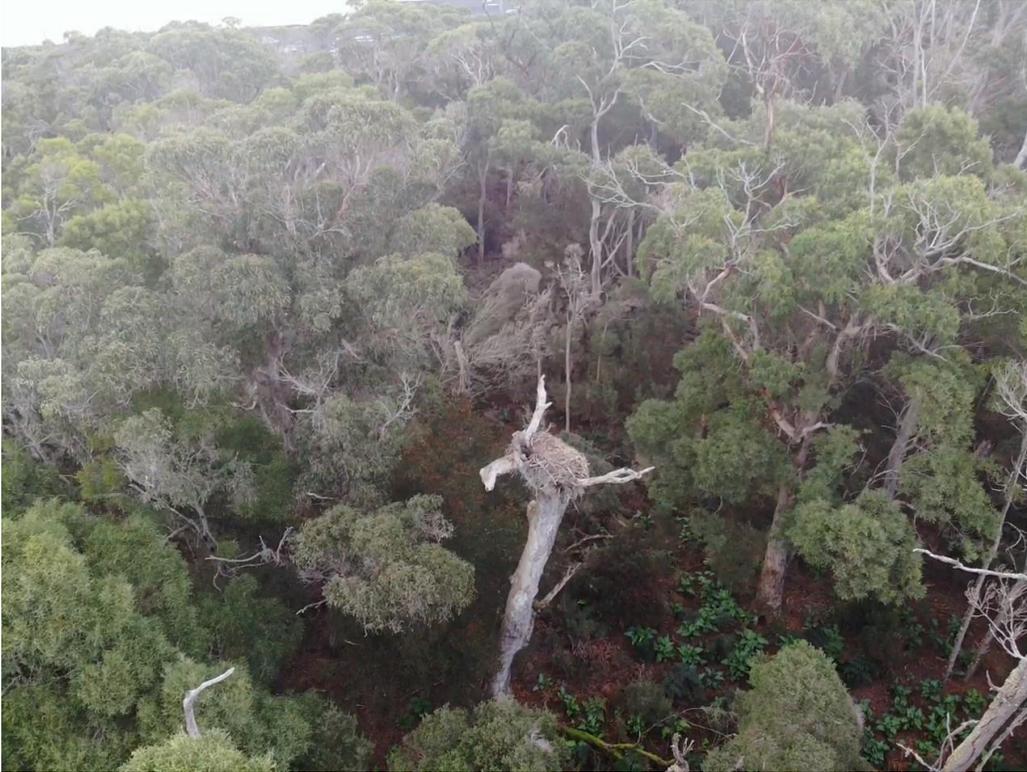
Nest is cited in a large dead eucalypt. A ground survey of the nest tree identified substantial damage had occurred to the tree, with the large overhead branches having now fallen. With a lack of surrounding trees in close proximity and the age and condition of the nest tree, it was determined it was unsafe to climb. The nest appears to be substantially damaged and is not likely to be a viable nest site in the future.

Site not installed, due to unsafe climbing conditions and lack of alternative equipment mounting options

Figure 14 - RI5 tree showing missing top limbs

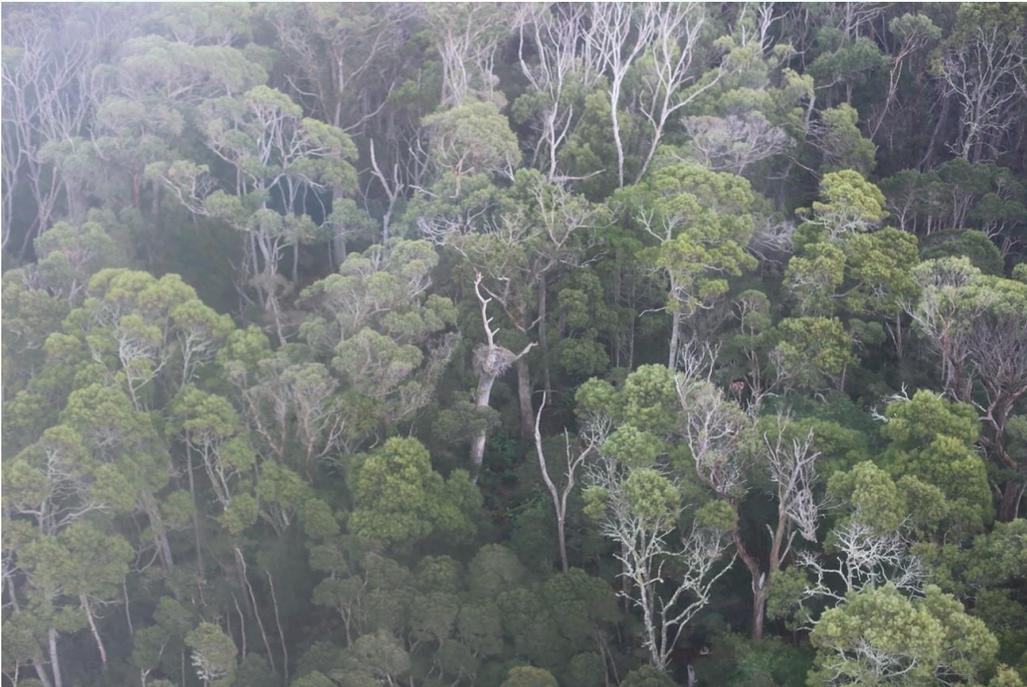
Figure 15 - RI5 tree from 2019 survey showing top limbs

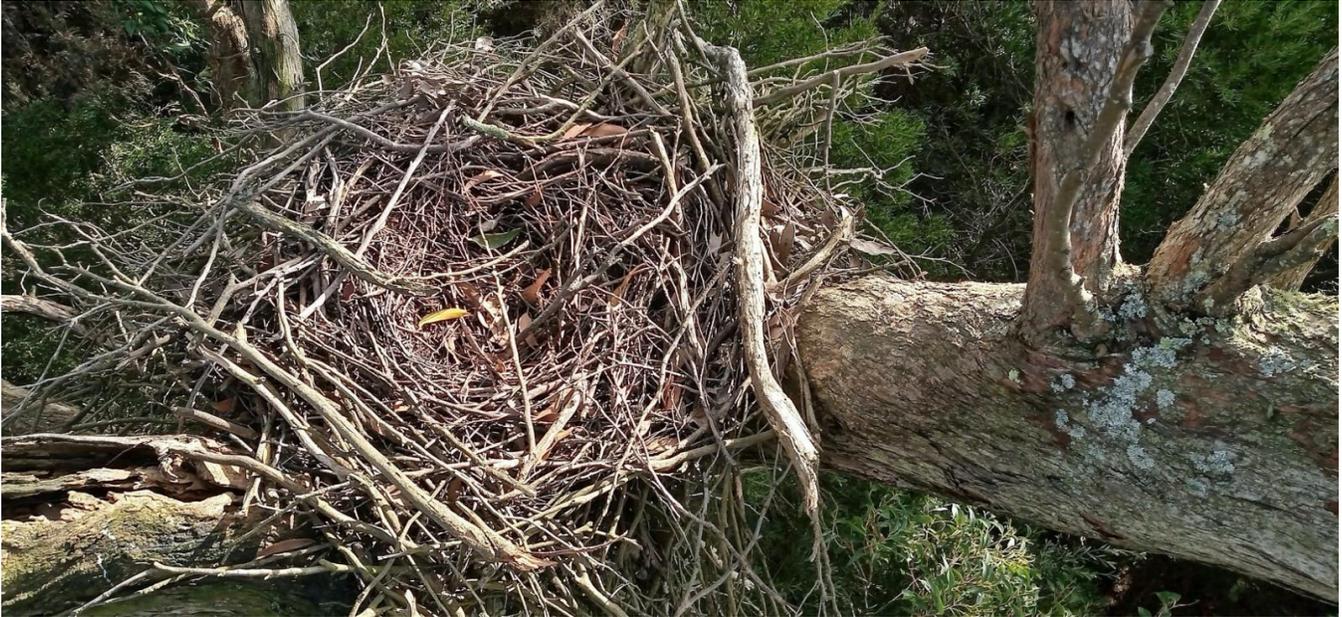
Figure 16 - RI9 Nest

Tasmanian wedge-tailed eagle nest located in a large eucalypt. Eagle was cited flying in area nearby during installation. Nest appears to be in good condition.
