RE: White Beach Quarry - Maintaining Environmental Limits Blasting Operations,

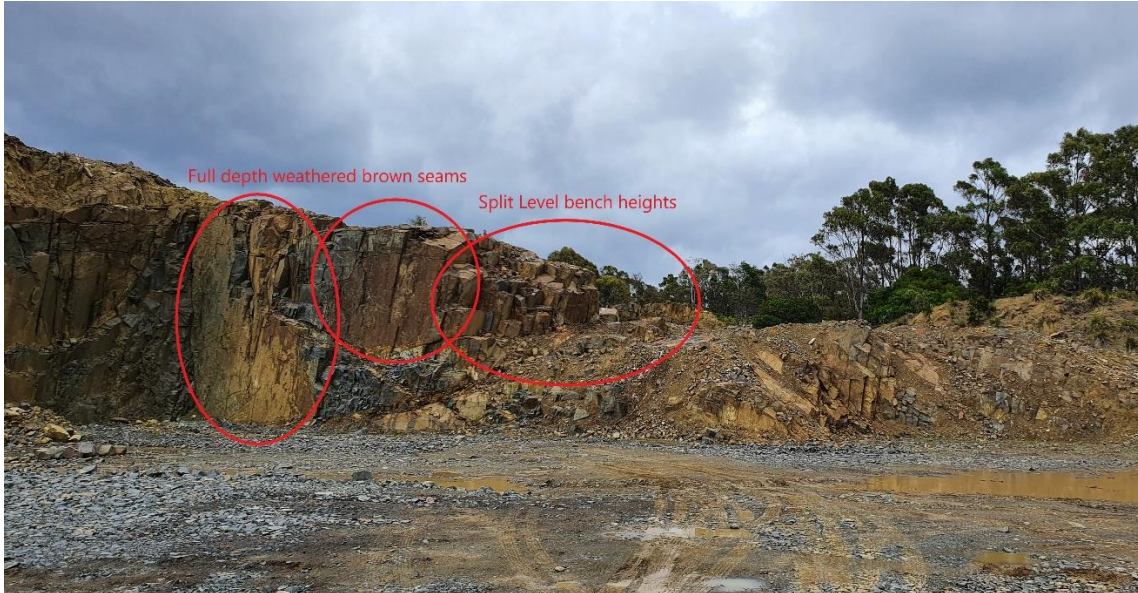
1)

Blasting development dolerite (first cut of weather dolerite) has a higher risk of exceeding overpressure limits due to the structure of the ground. Large preformed boulders separated by weathered brown seams within the rock can offer an easy route of escape for blast gas before breakage of rock occurs. Overpressure is harder to control on uneven or stepped benches due to variable stemming heights and intersections of material types. Development areas often consist of low bench heights without free faces which promote early gas escape or stemming rejection due to over confinement causing upward push.
