# Environmental Effects Report

ELT RECYCLING AUSTRALIA

<b>Project Name</b>		ELT Recycling Australia – Rocherlea Tasmania
<b>Project Owner</b>		Tony Song - CEO
<b>Project Manager</b>		Jason McGuirk
<b>Date:</b>		7 <sup>th</sup> October 2024

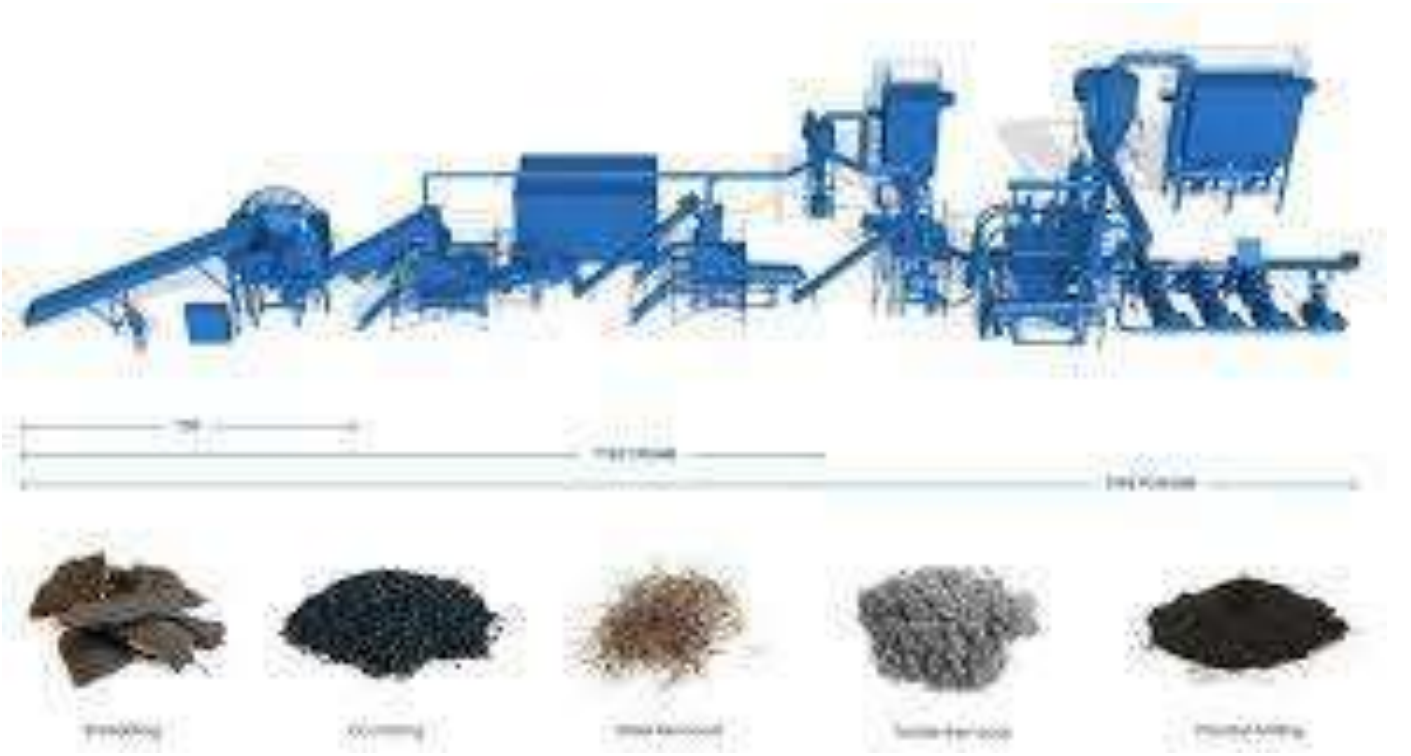
Figure 2: Shredding machine process

<b>Shredded Tyres</b>	Shredded tyres in jumbo bags stored waiting to be loaded into containers. There are never more than 50 tonnes of shredded tyres as per normal practice. It is important to note that these limits are a guide. Normal practice, as the tyres are processed once trucks are unloaded there will not be more than 1,000 EPU on site.
<b>Major equipment</b>	The facility will be fitted with a tyre shredding machine capable of shredding 500 EPU per hour. Two trucks and a two-tonne forklift will operate on site.  Examples of machinery required are provided in the following figure: <ul style="list-style-type: none"><li>• Figure 1: Shredding Machine</li></ul>
<b>Infrastructure</b>	There will be no changes to the buildings that currently exist at the proposed site. The property is 7300 sqm* with warehouse space of 1559m <sup>2</sup> .
<b>Proposal timeline</b>	A shredding machine has been delivered to the facility but has not been installed. Operation will commence as soon as the permits from the council and EPA are issued. The facility will be a permanent location for ELT Recycling Australia.  See shredding process in Figure 2.

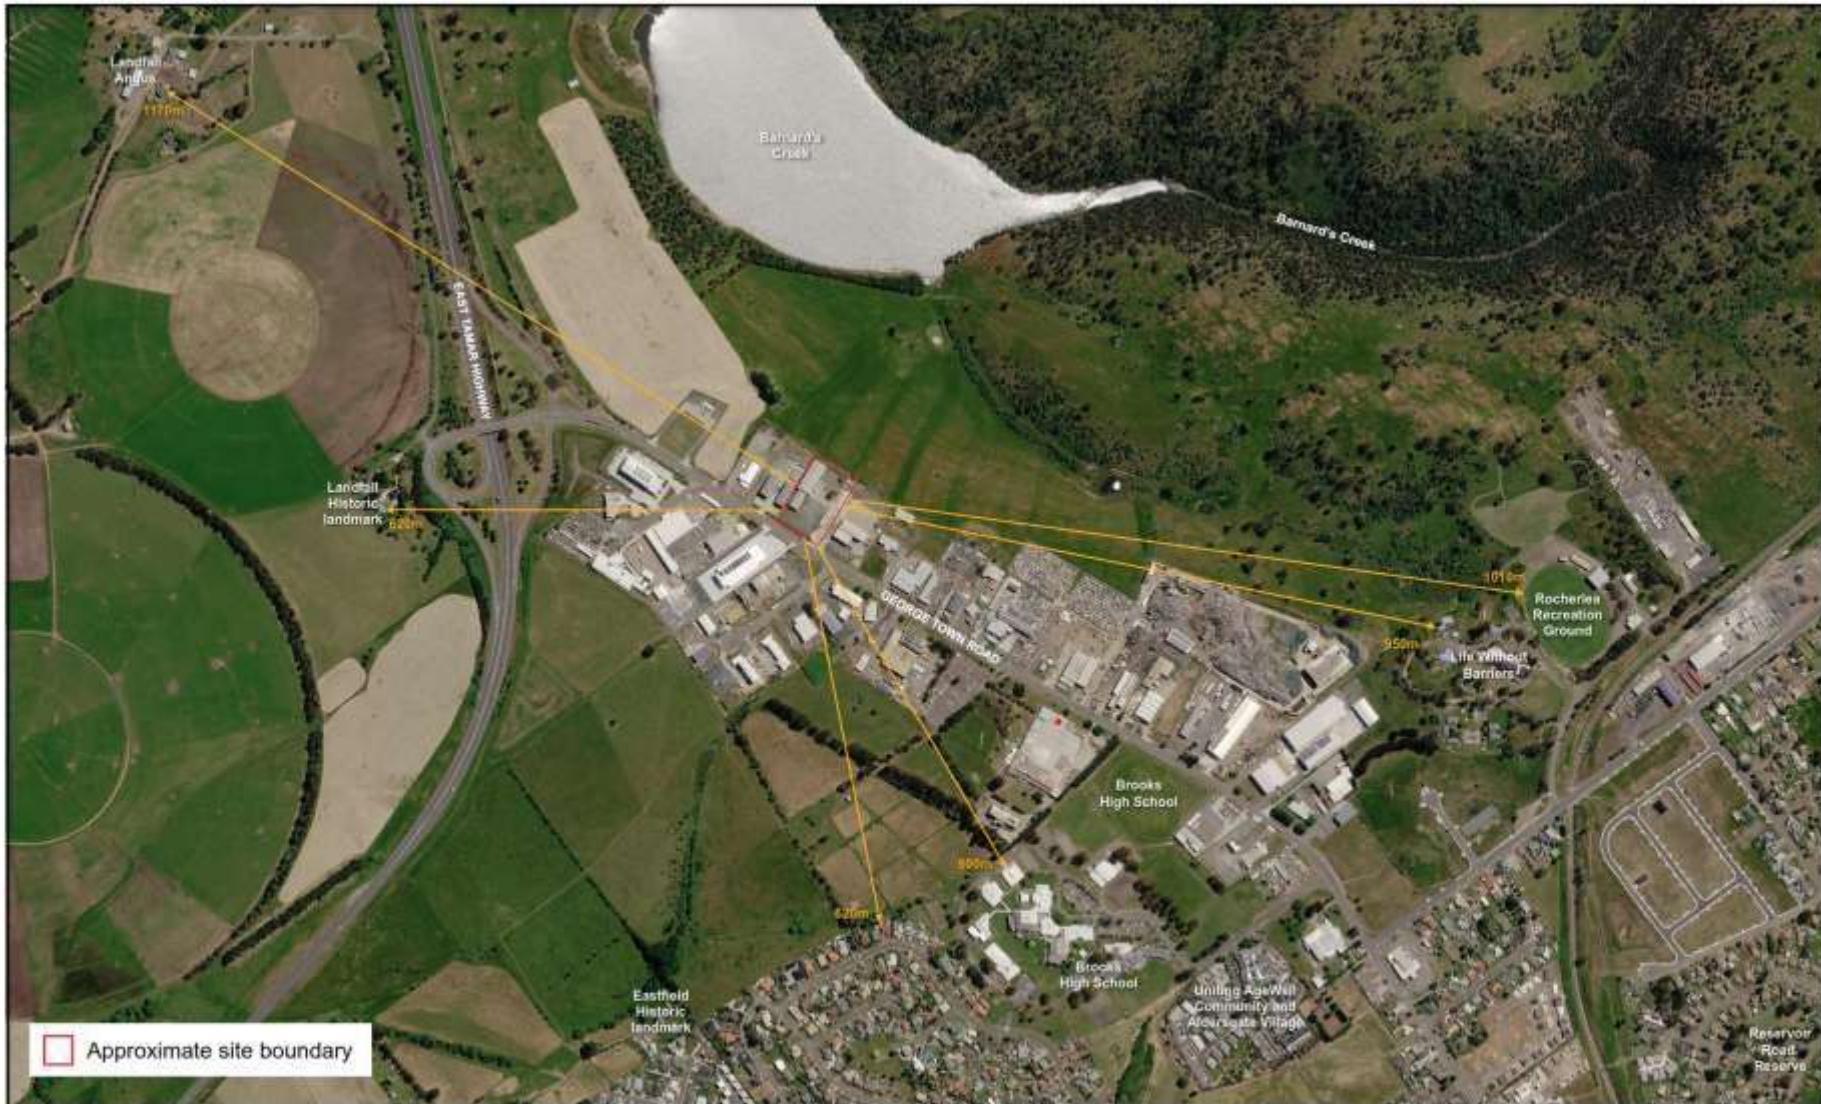
Figure 5: Surrounding Land Use Plan

Approximate site boundary

<b>Surrounding land use</b>	
308 George Town Road, Rocherlea, TAS 7248	
Date: 04/02/2026	Job number: 24102.01

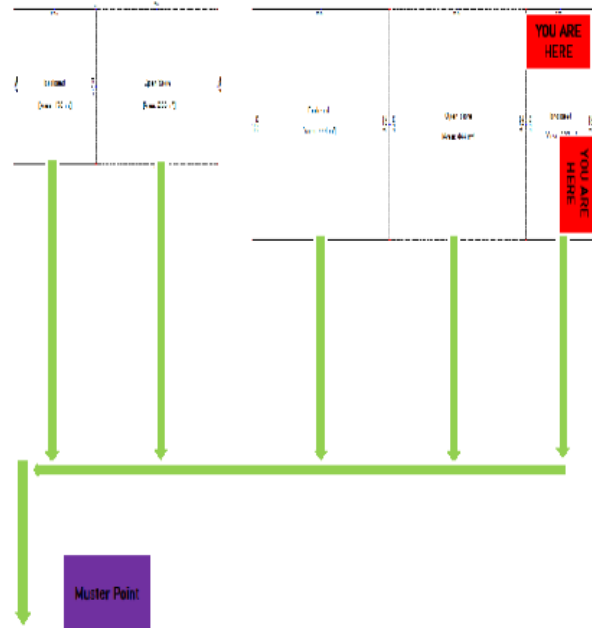
### EMERGENCY EVACUATION PLAN

**Leave building by nearest door.**

**Follow arrows**

**Muster Point – Across Road**

Leave the building immediately by the nearest exit: proceed to the Muster Point indicated in the map above: Remain in the Assembly Area until you receive further instructions from the Fire Warden or Emergency Personnel

Diagrams are to be displayed as recommended by the “You Are Here” points in the diagrams. This assists with the locations of fire safety equipment, paths of travel, exits, and Assembly Areas of the site. Copies of these diagrams are to be placed in the Emergency Management Plan (EMP), the Emergency Information Booklet (EIB) and are to be used for emergency procedures training.
