Development Proposal and Environmental Management Plan

Mountain Stream Fishery Pty Ltd
38036 Tasman Highway, Targa

Report to
Board of the Environment Protection Authority

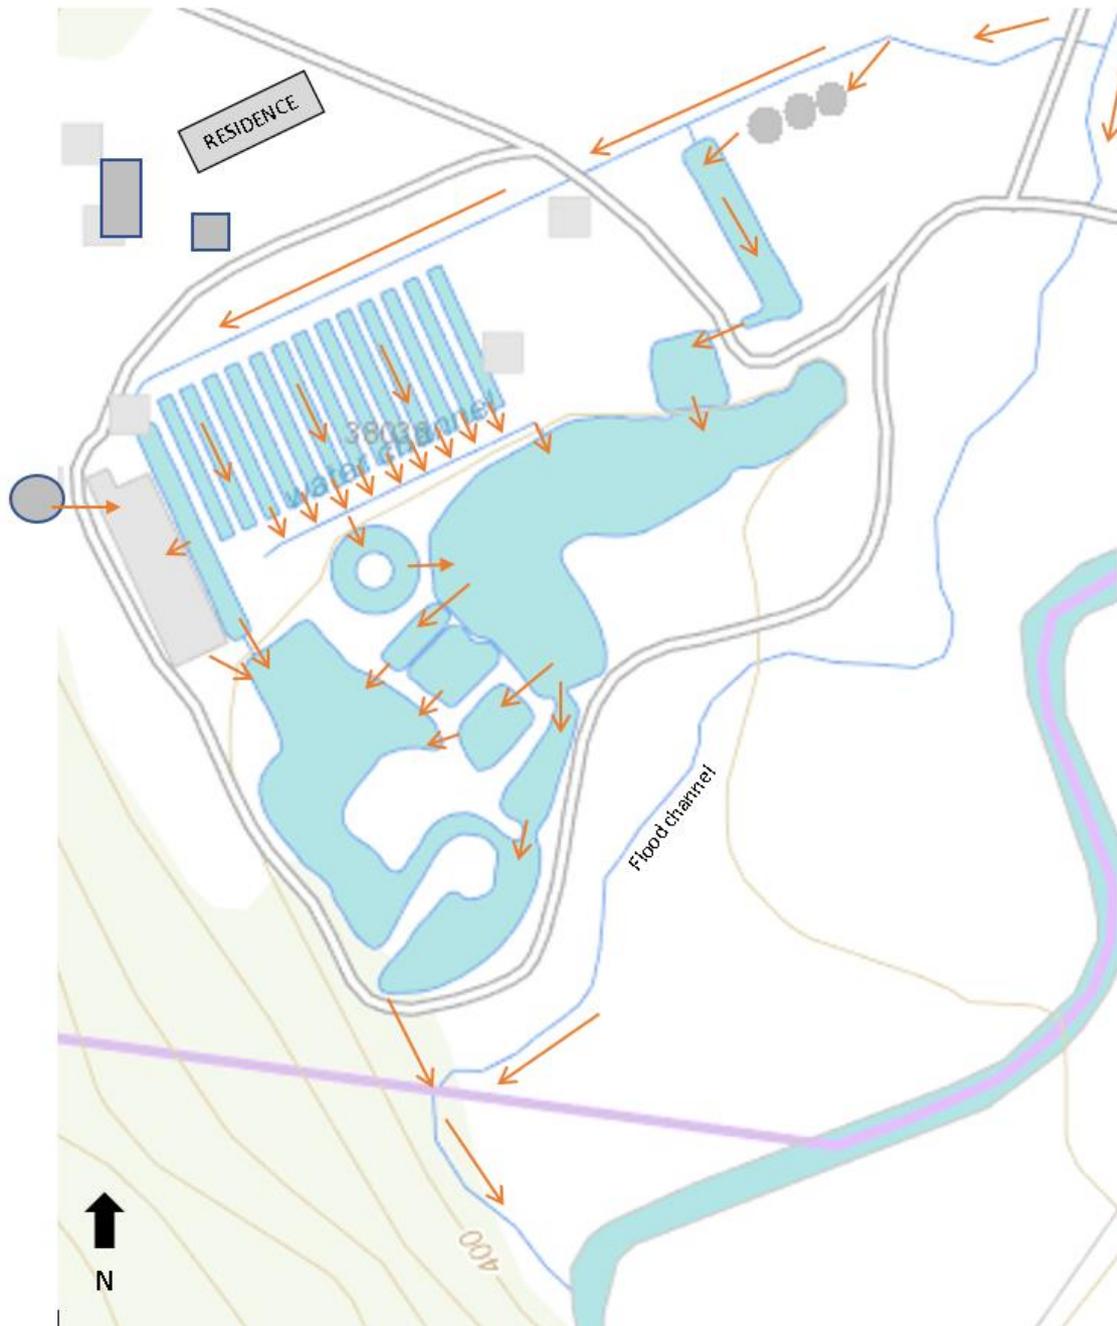
Figure 4: Site plan to show the direction of gravity-fed flow of water through the farm.

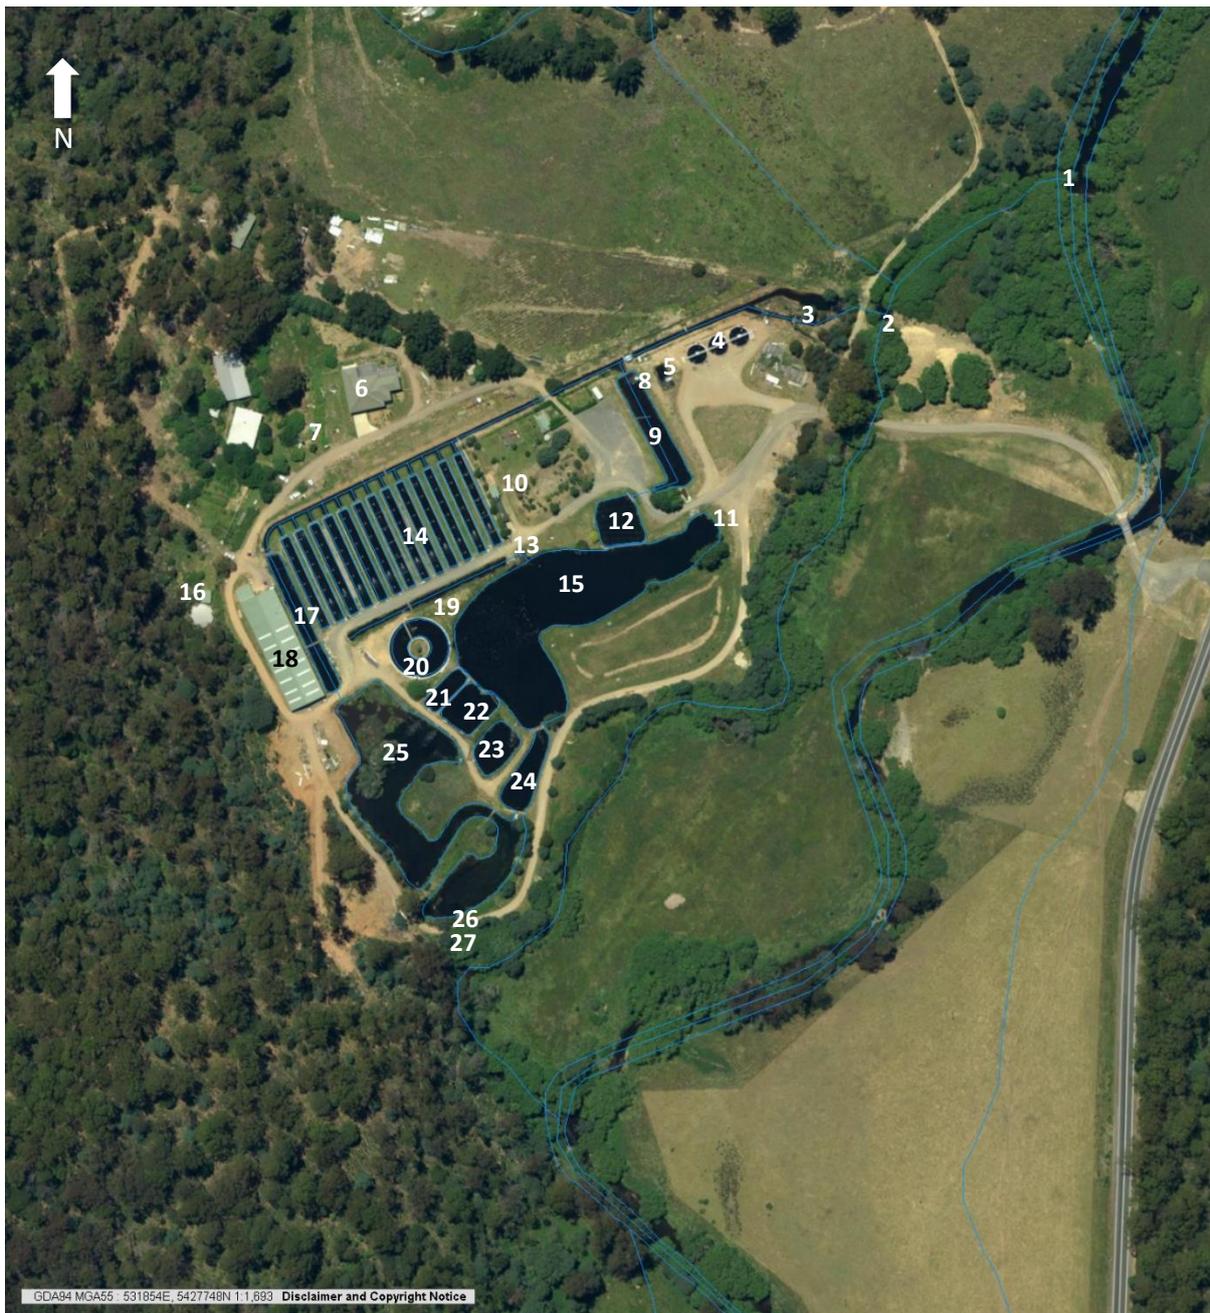
Figure 6: Site map of mountain stream fishery with **1)** Weir sample location, **2)** Wier, **3)** Drum filter and lift pump for tanks, **4)** Cement tanks, **5)** Quiescent pond, **6)** Residence, **7)** Diesel storage, **8)** Drum filter, **9)** Pond 22, **10)** Oxygen generation shed, **11)** Water recirculation pump 1, **12)** Pond 21, **13)** Water recirculation pump 2, **14)** Raceways (ponds 1-13), **15)** retention dam, **16)** Header tank, **17)** Pond 14, **18)** Hatchery, **19)** 'U' tubes **20)** Pond 15, **21)** Pond 16, **22)** Pond 17, **23)** Pond 18, **24)** Pond 19, **25)** Wetlands, **26)** Outfall from wetlands to flood channel, **27)** Effluent water sampling site.

There is a drum filter at the inlet to remove leaves and other detritus that floats down the river (predominantly feral willow leaf removal in Autumn), Figure 6. Detritus is collected at discharge channel and removed annually. First intake water for fish production is a 15kW lift pump for the three 200 m³ concrete fish production tanks, fish are stocked at no greater than 55 kg/m³ at peak production at the end of April each year.

Currently the site uses 43 ML of water per day. The water enters the site from the Inlet channel (see Item 1, Table 3). The supply of water is gravity fed through the farm, except during periods of low river flow. This usually occurs in the peak of summer and there are 2 pumps that are used to recirculate the fish-farm water (see Items 2 and 4, Table 3).

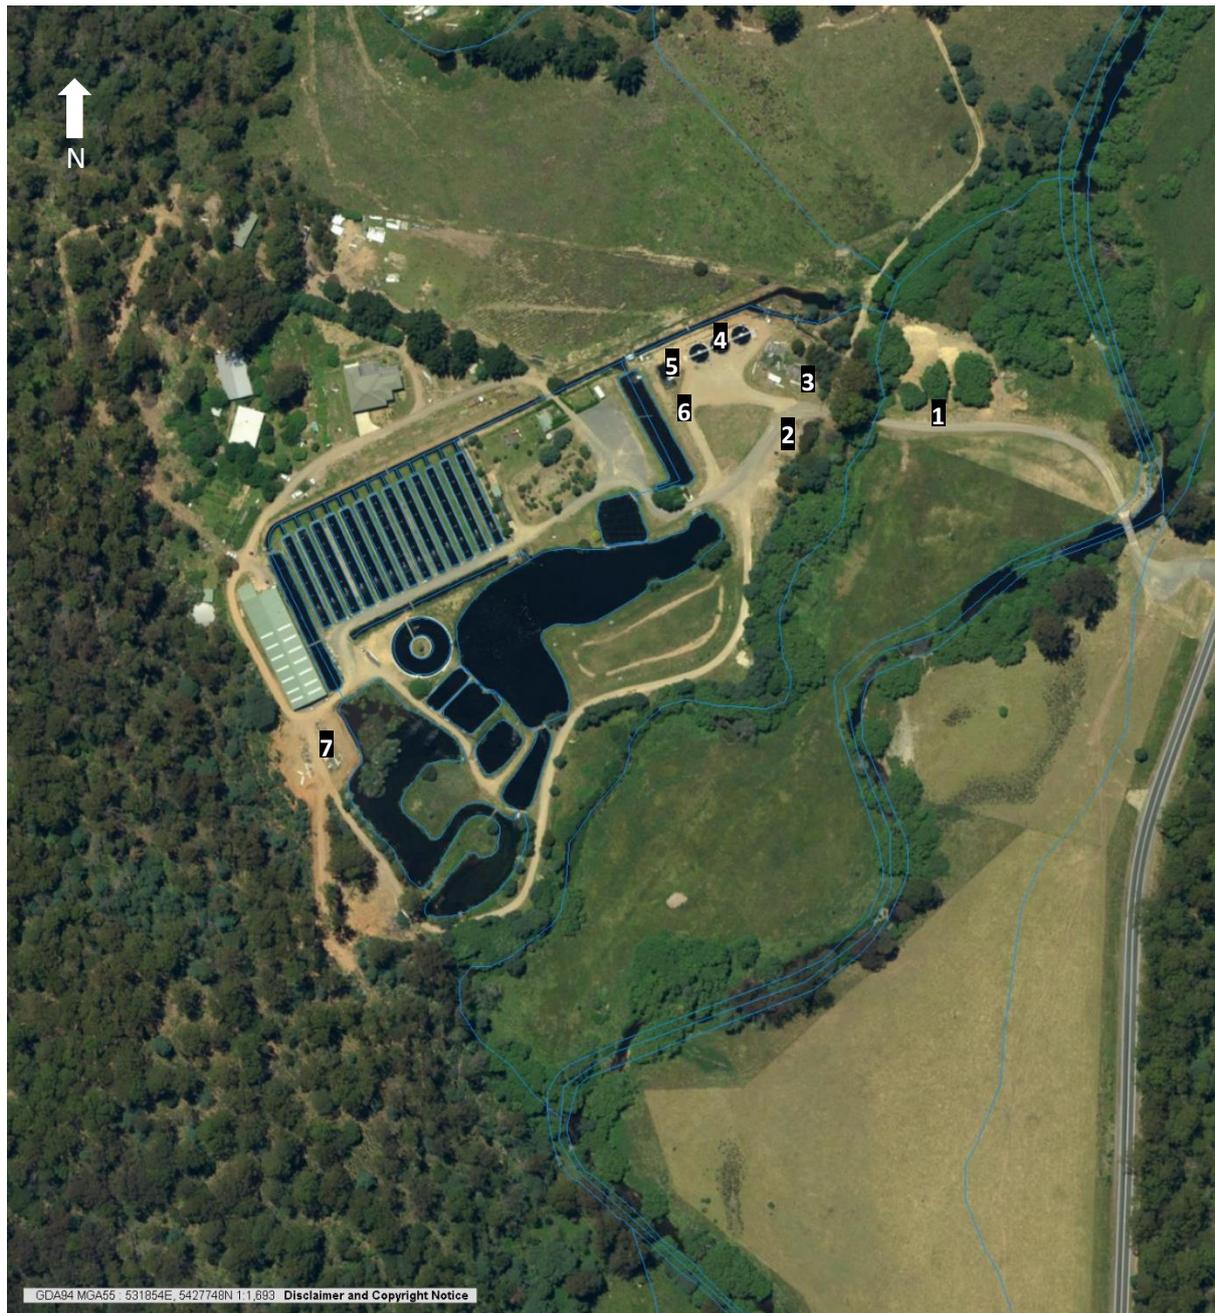
Figure 7: Site map of proposed changes with **1)** Truck Disinfection wash down Station, **2)** Hardwaste Collection Point, **3)** Visitor Check-in station, **4)** Cement tanks (commissioned 2017), **5)** drum filter, **6)** sludge tanks, **7)** Visitor and workers bio-secure check in station.

At the time of preparing this report the drum filter for the three concrete tanks has been installed but will not be commissioned until this DPEMP has been approved. This is the only construction envisaged for MSF.

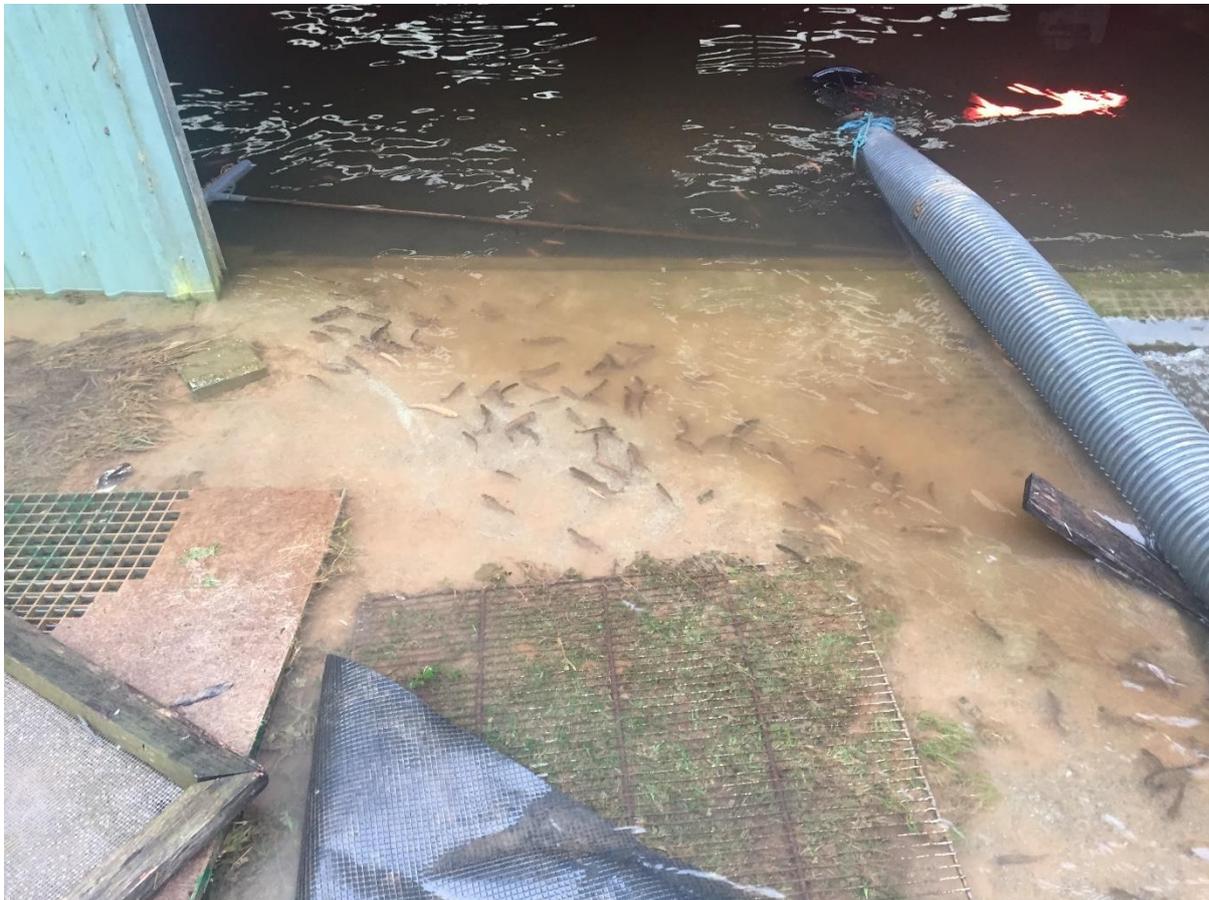
Figure 11: The entrance to the hatchery shed inundated with water during the '100-year flood' of June 2016.

In June 2016, the property experienced a one in one-hundred-year flood. The whole property was inundated (see Figure 11), however, the production fish had already been sent to sea sites minimizing the risk of escapees. The hatchery building lost in the order of 35 000 fish that were < 40 g in size and an unknown quantity of brood stock escaped. Discussions with the water management department of DPIPWE and Inland Fisheries Service concluded that in that instance, no storm water protection would have stopped inundation of MSF. The only remedial action that could be taken was to ensure all screens were clear of debris enabling flood waters to subside through controlled outlets (see ASOP2807 Preventing Accidental Release, Appendix 6).

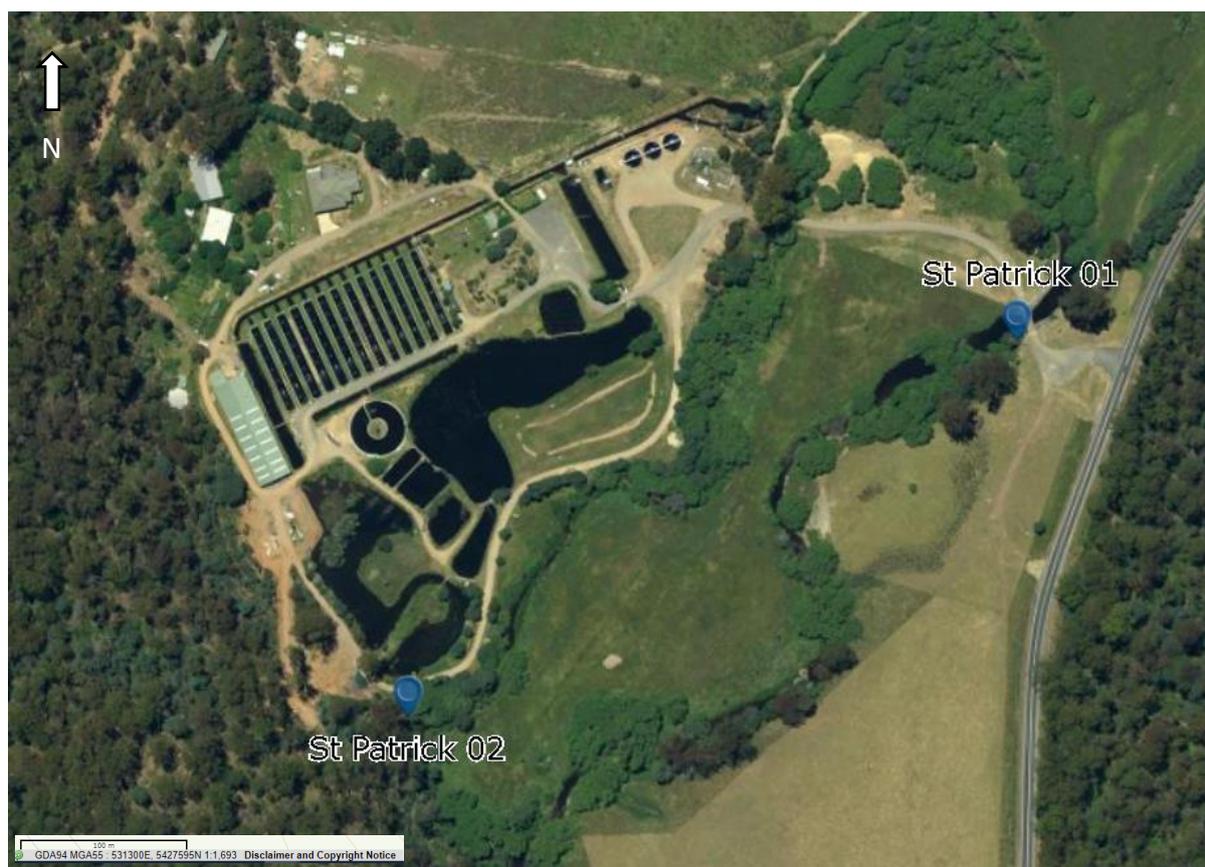
Figure 13: Location of sites sampled in the AUSRIVAS survey conducted by Walsh (2019) (sourced from DPIPW (n.d); scale 1:3,385) .

A series of surveys was conducted by Todd Walsh of Kanunnah Pty Ltd during 2017 and 2018. Two sites were chosen by Mr Wash for sampling that represented “upstream” of the site and “downstream” of the site, see Figure 13. This report demonstrated that the sites (see Figure 13) both upstream and downstream had a rating of “A” and that a range of sensitive taxa were recorded, including 7 families of Trichoptera (Caddis-fly) and 2 families of Ephemeroptera (Mayflies). Overall, it was concluded that *‘There is no significant difference in the health of the upstream or downstream sites according to AusRivAS results’* (Walsh, 2019). The full report is available in Appendix 7 and a summary of the results is provided in Table 6.

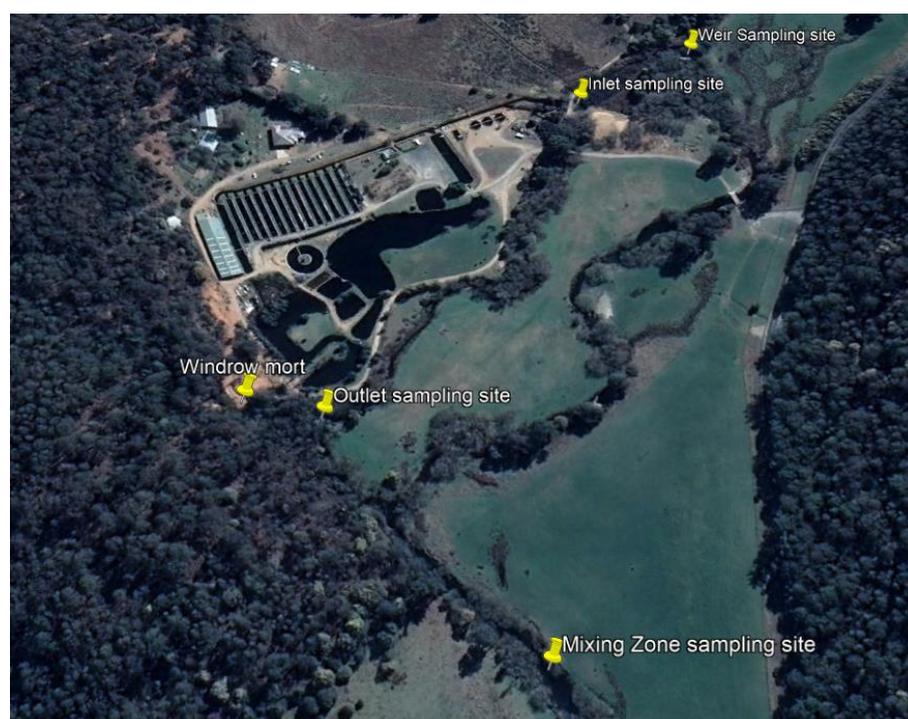
Figure 14: Mountain stream fishery water quality monitoring sites from 2018 onwards

Grab samples are taken consecutively from the weir, inlet, outlet and 250m downstream site starting at 8am with the last sample taken at around 9am from the 250m site. Water samples are sent to AST labs for analysis. Samples are tested for Conductivity, Total Suspended Solids (TSS), Ammonia, Nitrate, Nitrite, Nitrate+Nitrite, Total Nitrogen, Total Kjeldahl Nitrogen (TKN), Biological Oxygen demand (BOD), Dissolved Reactive Phosphorus (DRP) and Total Phosphorus (TP). Beginning in November 2020 Biological Oxygen Demand will be

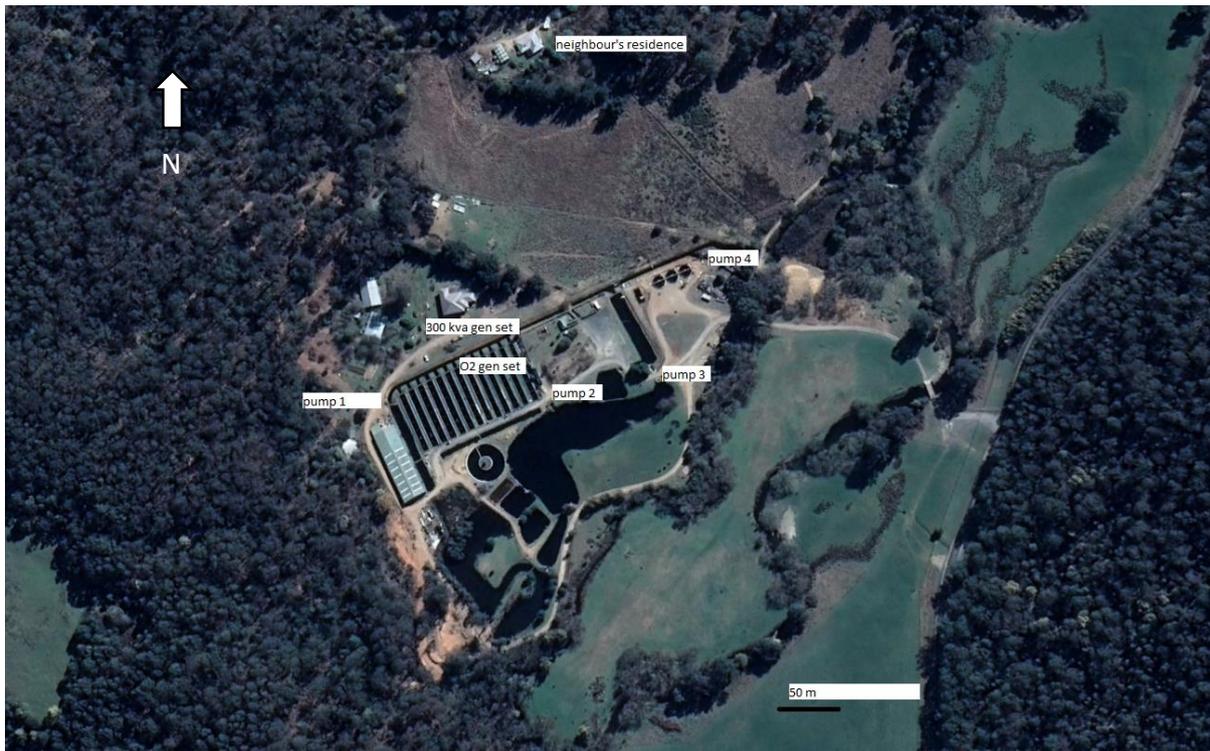
Figure 21: Map of noise producing equipment at MSF (Google Maps 2019).

Table 12 The locations of each source and the nearest neighbour have been identified in Figure 21. For full details see the report (Appendix 11).

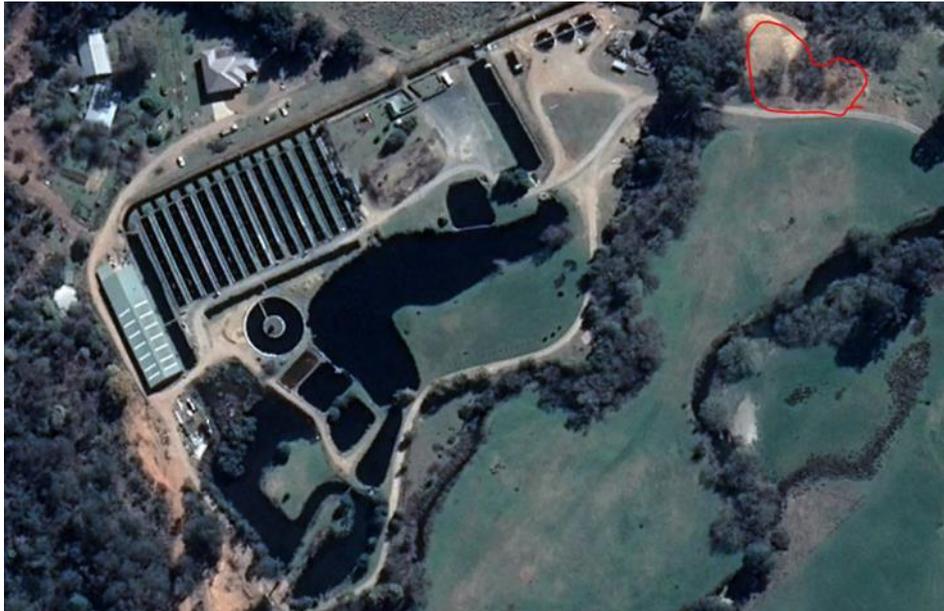
Figure 23: Location of area for past sludge and rock disposal on site. Future sludge removal will be transported off-site for composting.

The waste from the hatchery and raceways is settled in the retention dam and wetland serpentine. Ponds 15 and 19 also serve to capture settled waste product and approximately 30 tonnes of sludge are removed during each de-sludging event. De-sludging of the ponds happened when work on the ponds was required. In the last 5 years this has happened twice. The sludge was dried out as much as possible, however the dilution of sludge amongst the soil and rock is high. Ponds were isolated, water was blocked from entering and the ponds were pumped dry to allow evaporation to occur. After a period of days an excavator was employed to extract dry waste sludge which has in the past, been trucked to a section of the farm and spread out and covered with wood chips supplied by HST Pty Ltd. This waste was then transported to an appropriate area of the farm, see Figure 23. Any future sludge removal from the ponds will be trucked offsite in a similar process to the sludge collected from the drum filter (see above).

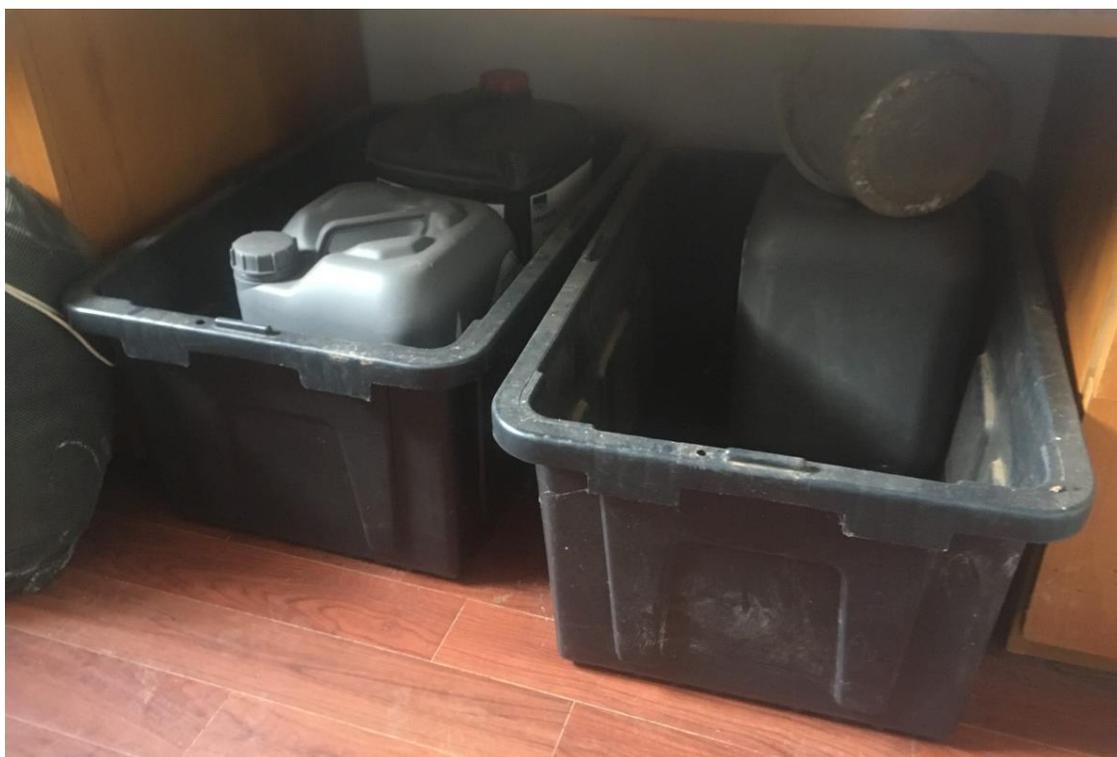
Figure 24: Bunding of chemicals in the hatchery at MSF.

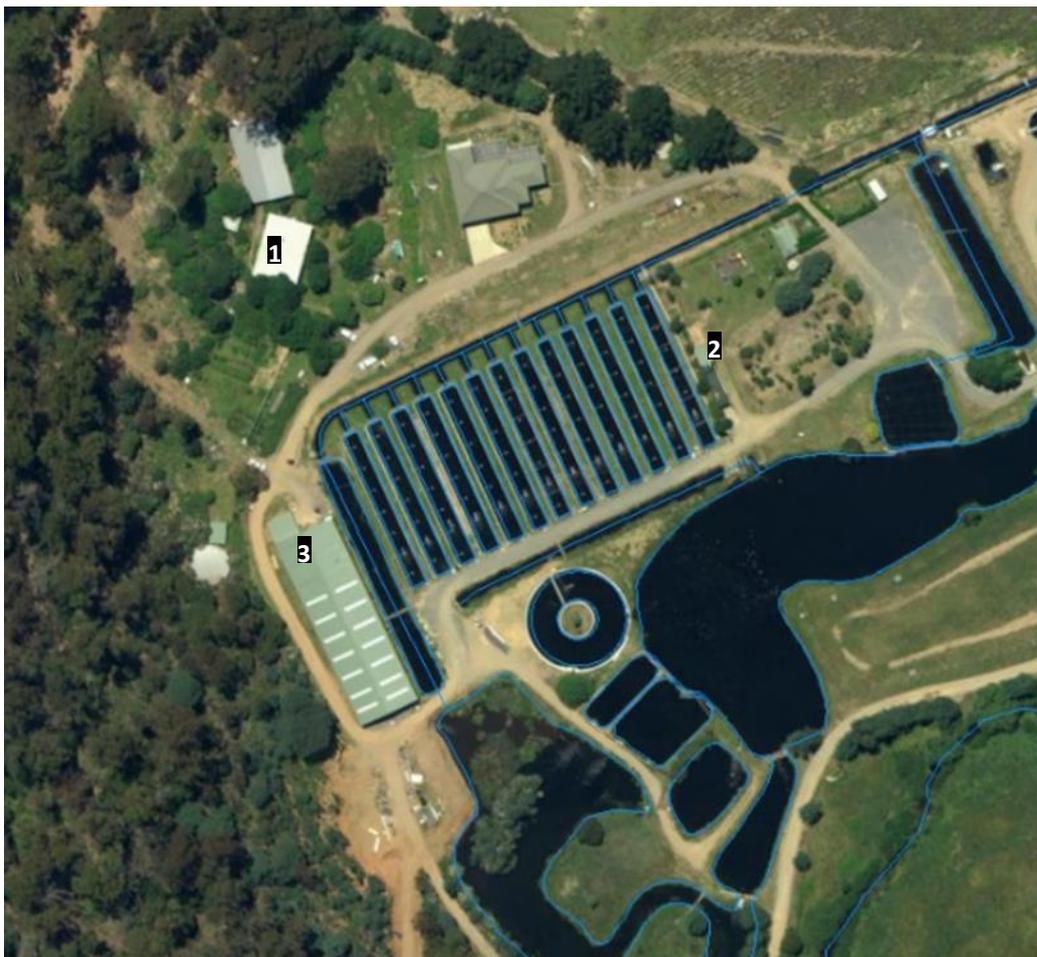
Figure 25: Site map with locations of fuel and chemical storage, **1)** diesel fuel storage, **2)** Oxygen generation shed, **3)** main chemical storage
