MARINE NATURAL VALUES ASSESSMENT FOR PROPOSED NATIVE OYSTER REEF RESTORATION AT DIXONS BEACH, TAROONA, TASMANIA

Reef Builder Southeast Tasmania Project

Report to
NRM South
April 2022

MARINE NATURAL VALUES ASSESSMENT FOR PROPOSED NATIVE OYSTER REEF RESTORATION AT HELLIWELLS POINT, WOODBRIDGE, TASMANIA

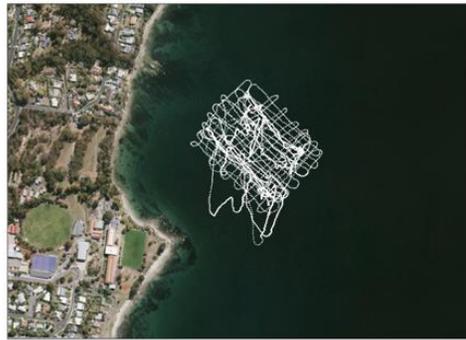
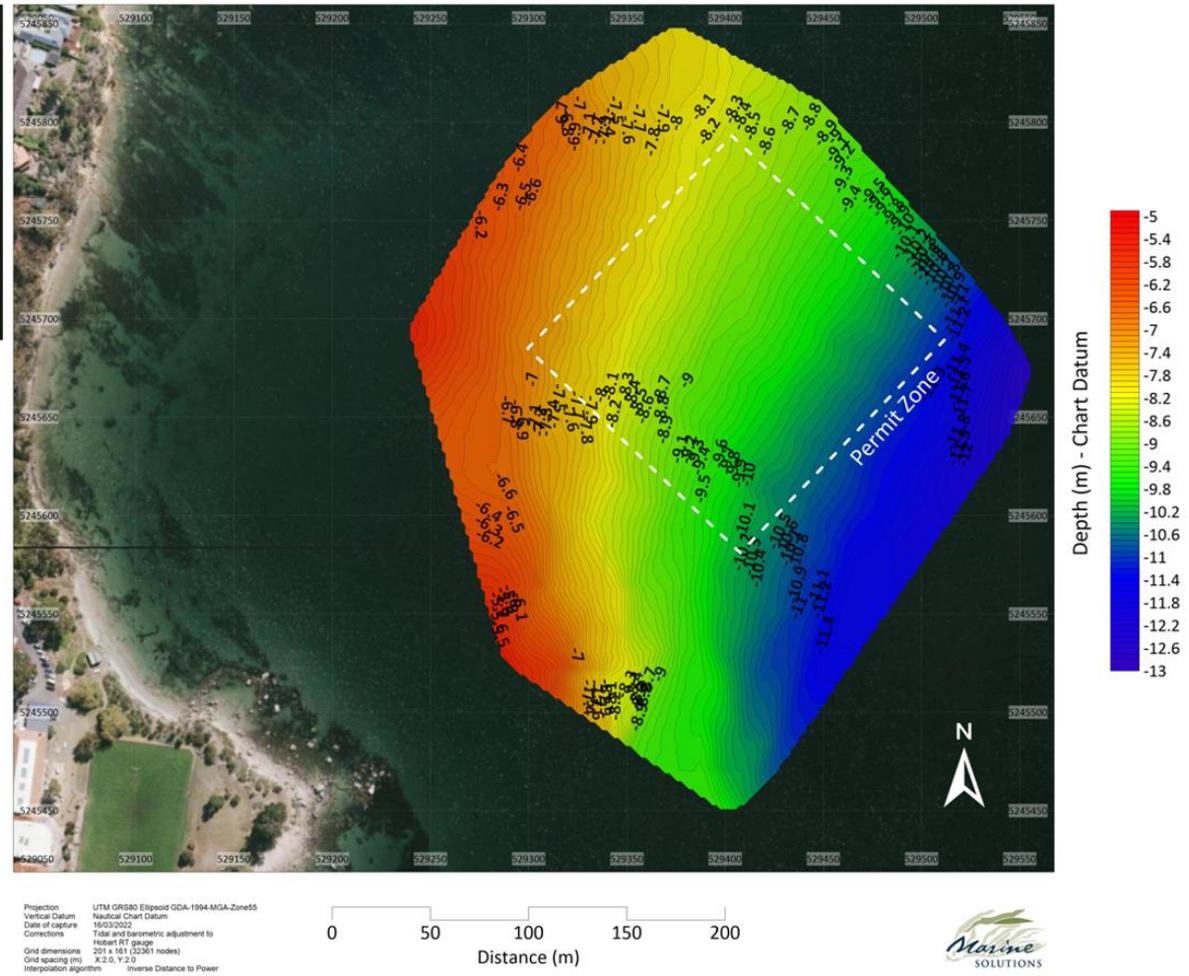
The bathymetry across the study area consists of gently sloping seabed (Figure 2). Depth ranged from 5 m close to shore, increasing gradually to 13 m offshore.

Figure 2. Bathymetric contour map of the seabed of the survey area (proposed reef area (150m x 150m) boundaries indicated by white dotted line) at Dixons Beach, Tarooma. Corrected to Chart Datum. To the left is a schematic of the tracks during the bathymetric survey.

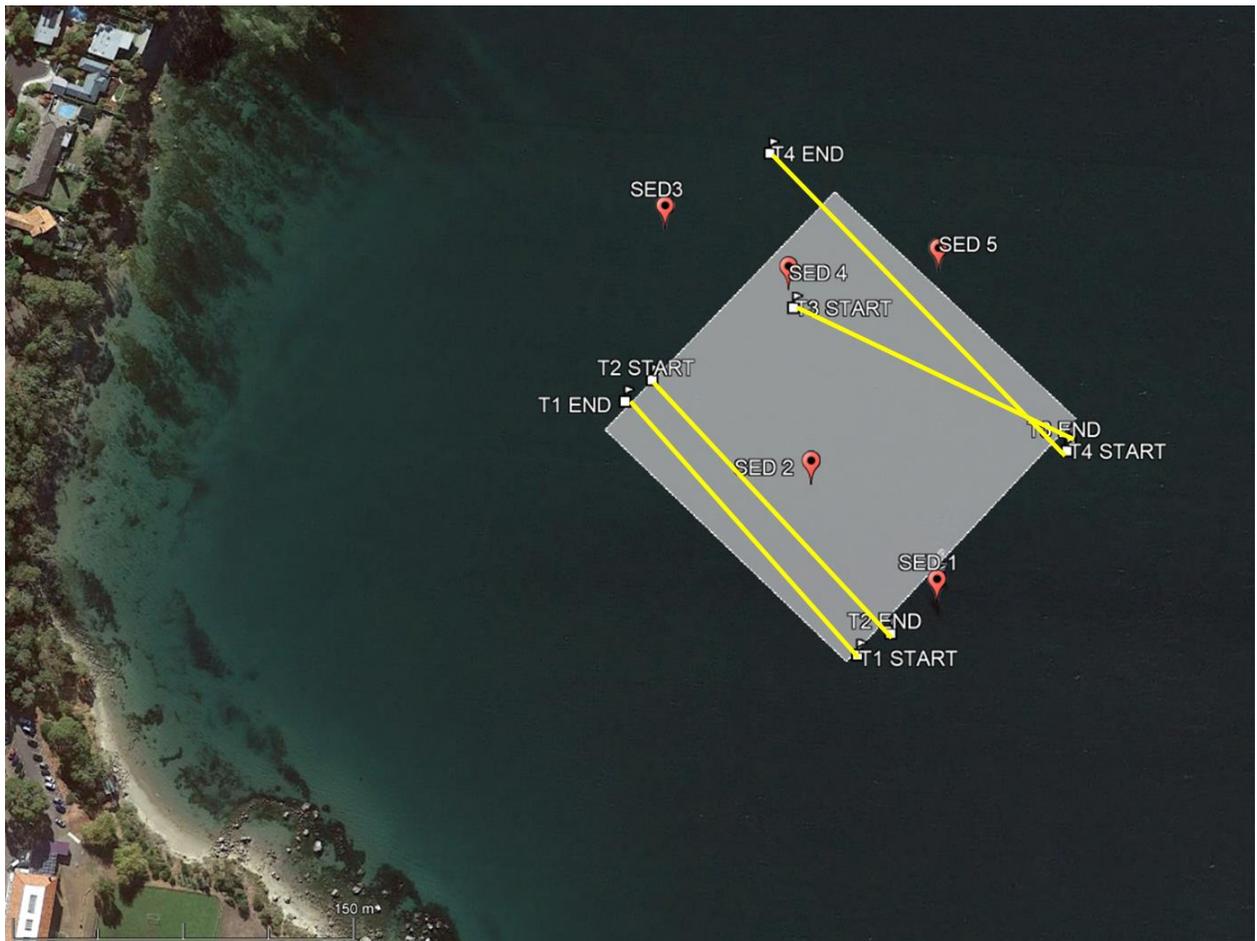
Figure 3. Map showing location of habitat survey diver transects (yellow) and sediment sample sites (red), relative to the proposed native oyster reef restoration area (in white).

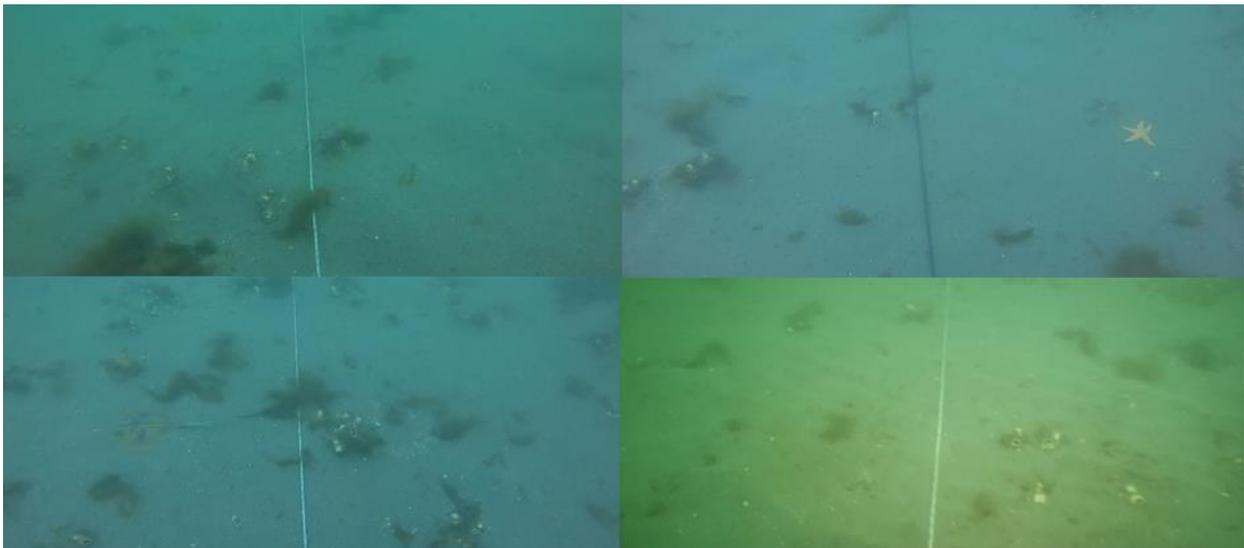
The substrata was relatively consistent throughout the transects with habitat consisting of soft sand and silt. There were patches of substrate densely covered in the ascidian species *Pyura stolonifera*. Patches of mostly dead New Zealand screwshell were also observed, with several live specimens found within. Dead scallop shells were also observed within these patches (Figure 4).

Figure 4. Images from video transects from the habitat survey at Dixons Beach, Tarooona.

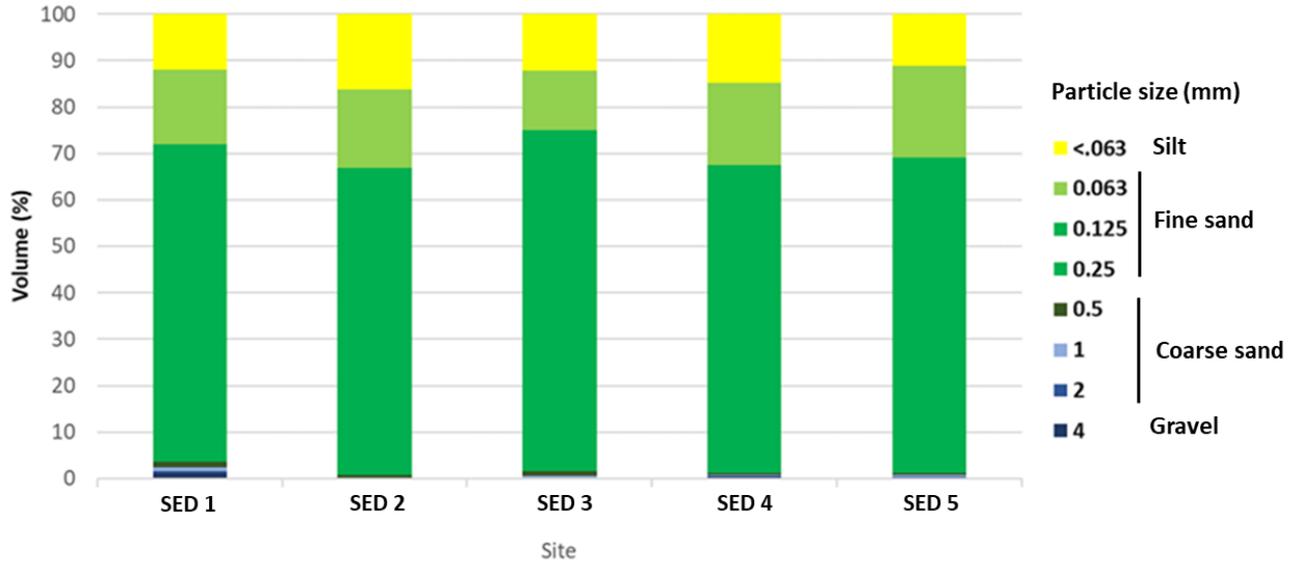
Particle size analysis indicated that sediments at the Dixons Beach site were predominantly fine sand with a small proportion of silt (Figure 6), typical of an area with low hydrodynamic energy.

Figure 6. Results from particle size analysis at each of the five sites, Tarooma.

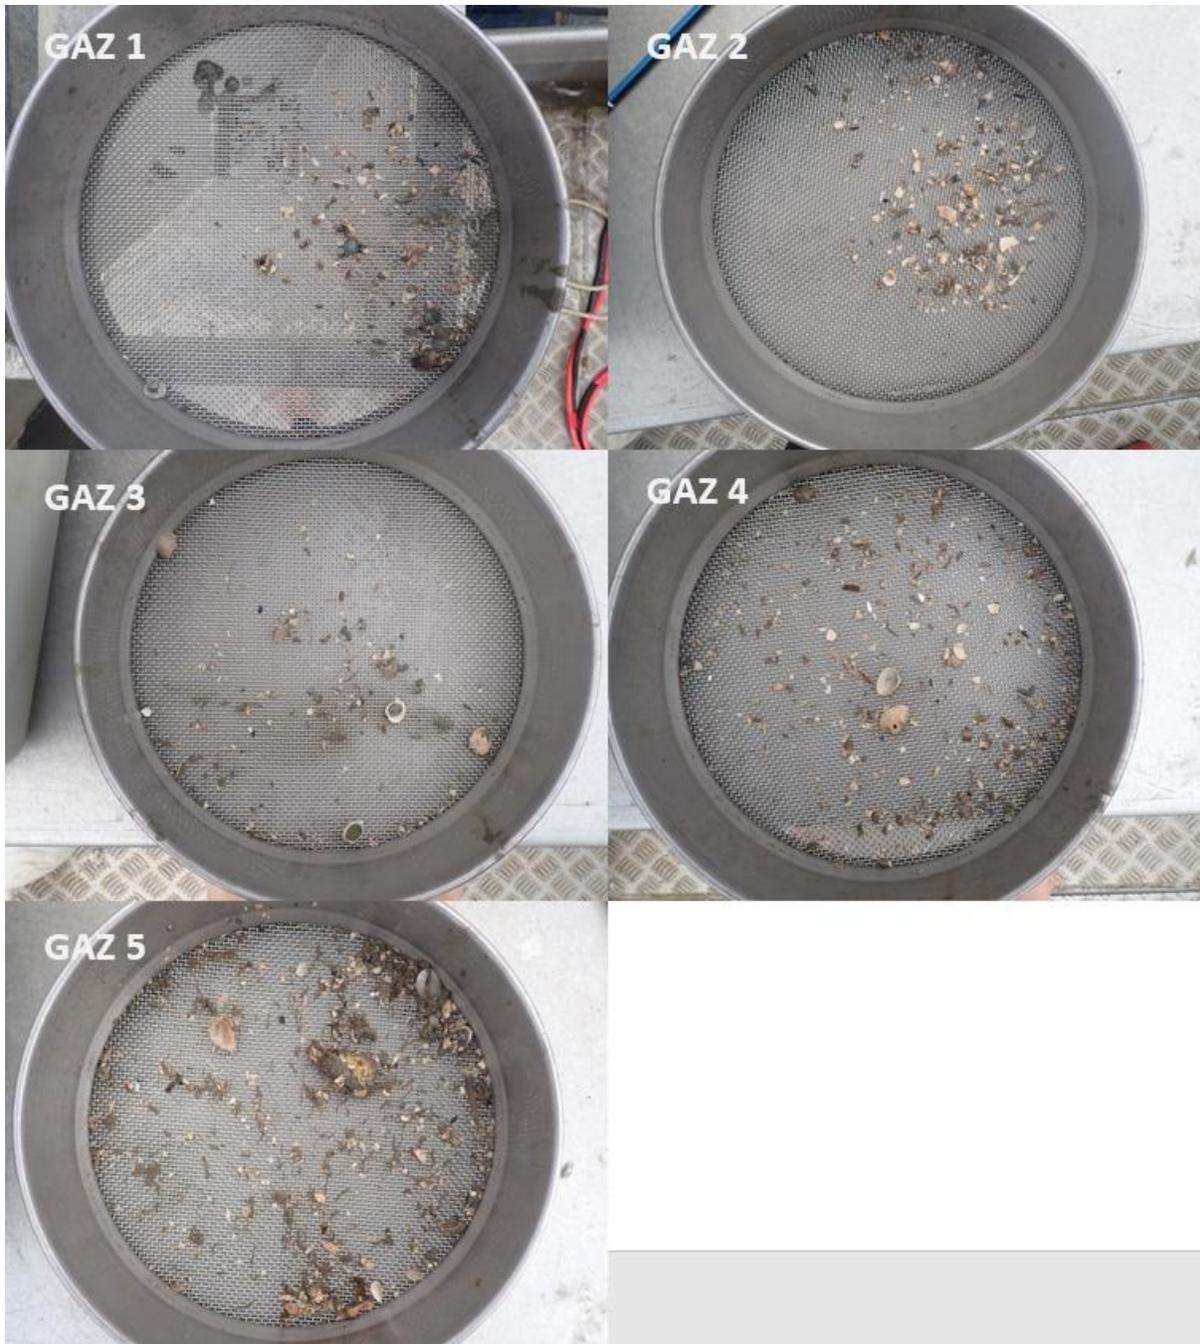
Gunn's screwshell were not identified from any of the samples collected at Dixons Beach, Tarooma (Figure 7). The samples consisted mostly of shell fragments and shell grit. These shell fragments were difficult to identify on a species specific level due to their small size, however some fragments of the invasive New Zealand screwshell *Maoricolpus roseus* were likely present. Sample GAZ 5 contained a piece of ascidian (*Pyura stolonifera*, observed in abundance in handfish surveys, see Section 6.2). Samples GAZ 3, 4 and 5 all contained whole mollusc and bivalve shells, but no live specimens (Figure 7).

Figure 7 Images of benthos samples from targeted *Gazameda gunnii* grabs at Dixons Beach, Taroon.

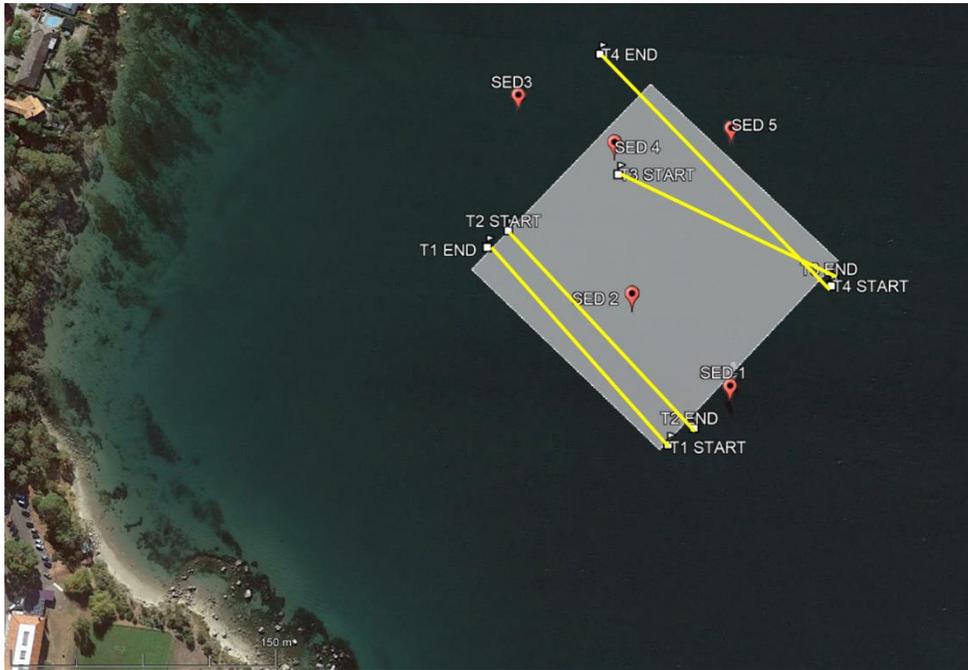
Figure 8: Locations of sampling completed at Dixons Beach, see T1 – T4 (yellow transect lines) for location of habitat survey diver transects.

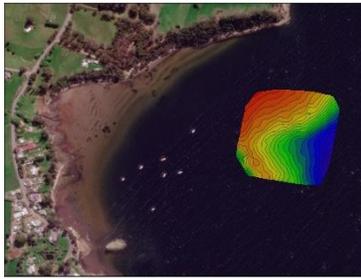
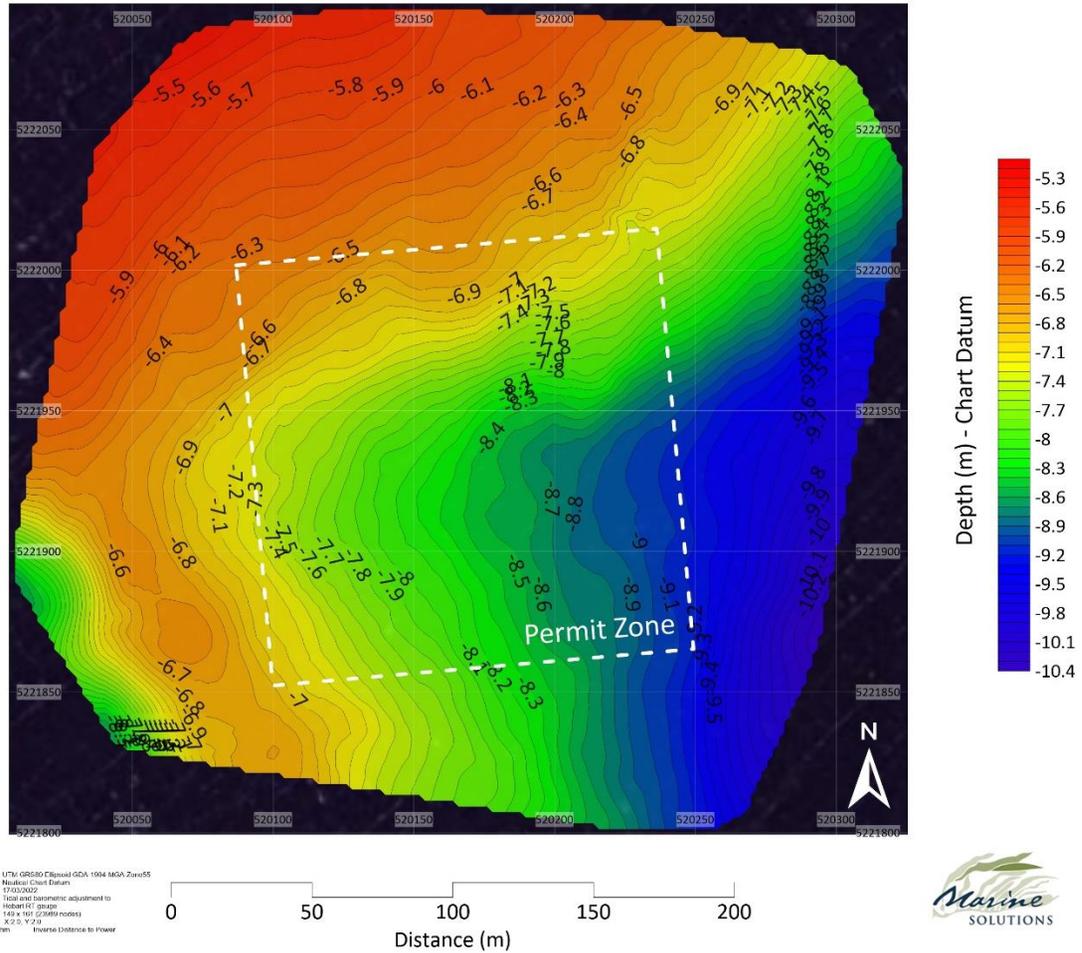
The bathymetry across the study area consists of gradually sloping seabed that follows the shape of the shoreline. (Figure 2). Depth ranged from 5 m inshore, to 10 m offshore, and presents suitable depths for the proposed native oyster reef restoration.

Figure 2. Bathymetric contour map of the seabed of the survey area (proposed reef area (150m x 150m) boundaries indicated by white dotted line) at Helliwells Point, Woodbridge, corrected to Chart Datum.

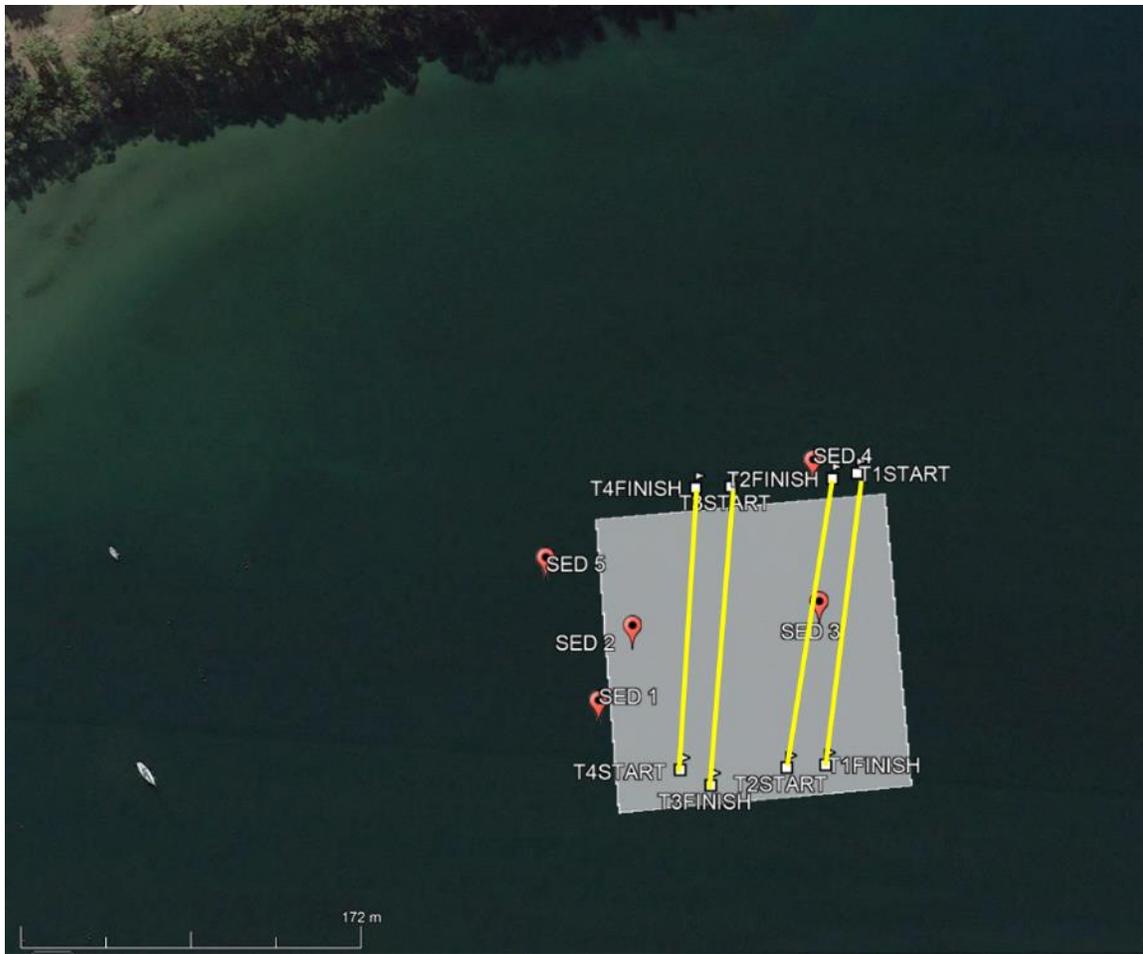
Figure 3 Location of the dive transects (yellow) and sediment grabs (red) relative to the reef permit area at Helliwells Point, Woodbridge

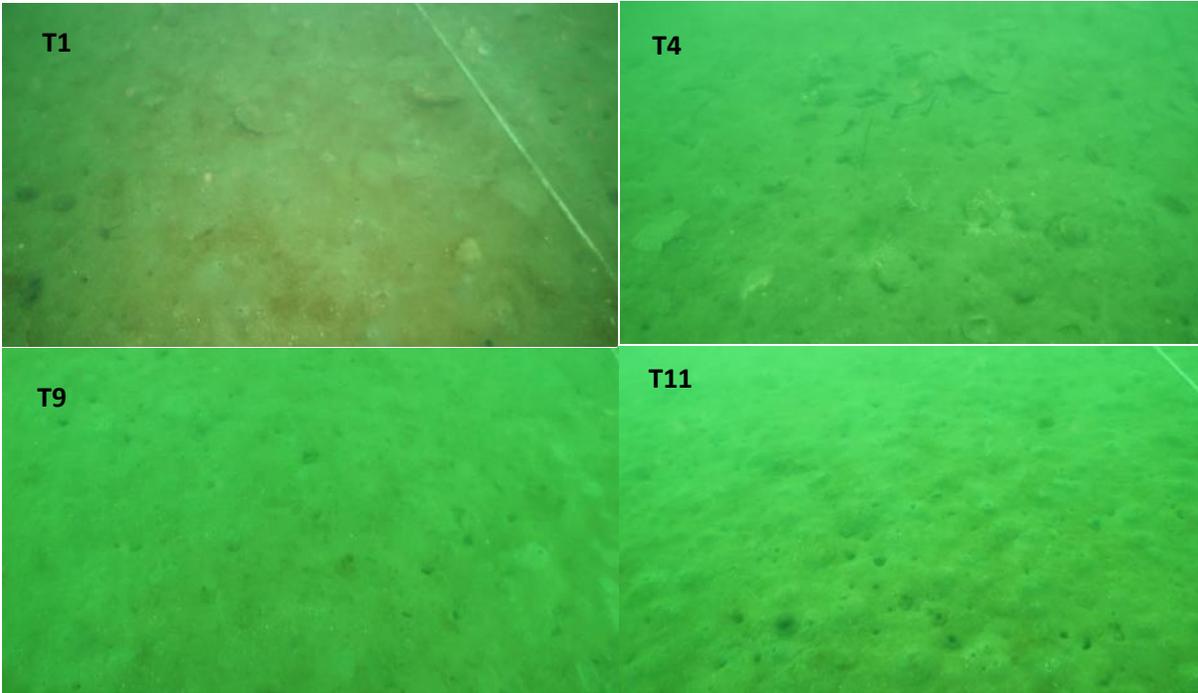
Sand and silt made up the substrate on all transects, with the surface often covered in a layer of shell grit. The bottom was very soft and light silt was easily disturbed. There was a dense cover of dead scallop shells on all transects and fan worms (*Myxycola infundibulum*) were common. No threatened species were observed in the underwater habitat survey. No suitable substrata was identified for Giant kelp marine forests to form. The full list of species identified during the habitat survey is included in Appendix 3. Video files are listed in Appendix 4 and are available from Marine Solutions on request.

Figure 4 Images of benthic habitats throughout reef permit area at Woodbridge.

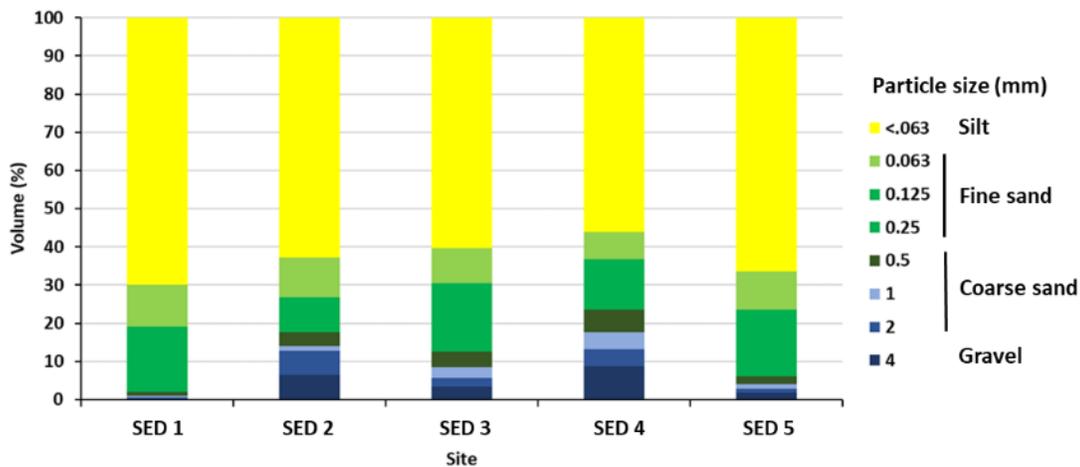
Particle size analysis indicated the majority of sediments were mostly fine silt at < 0.063 mm particle size (Figure 5). The deposition of sediments in this area are therefore likely mostly from riverine deposition upstream and runoff from surrounding lands.

Figure 5. Results from particle size analysis at each of the five sites at Helliwells Point, Woodbridge.

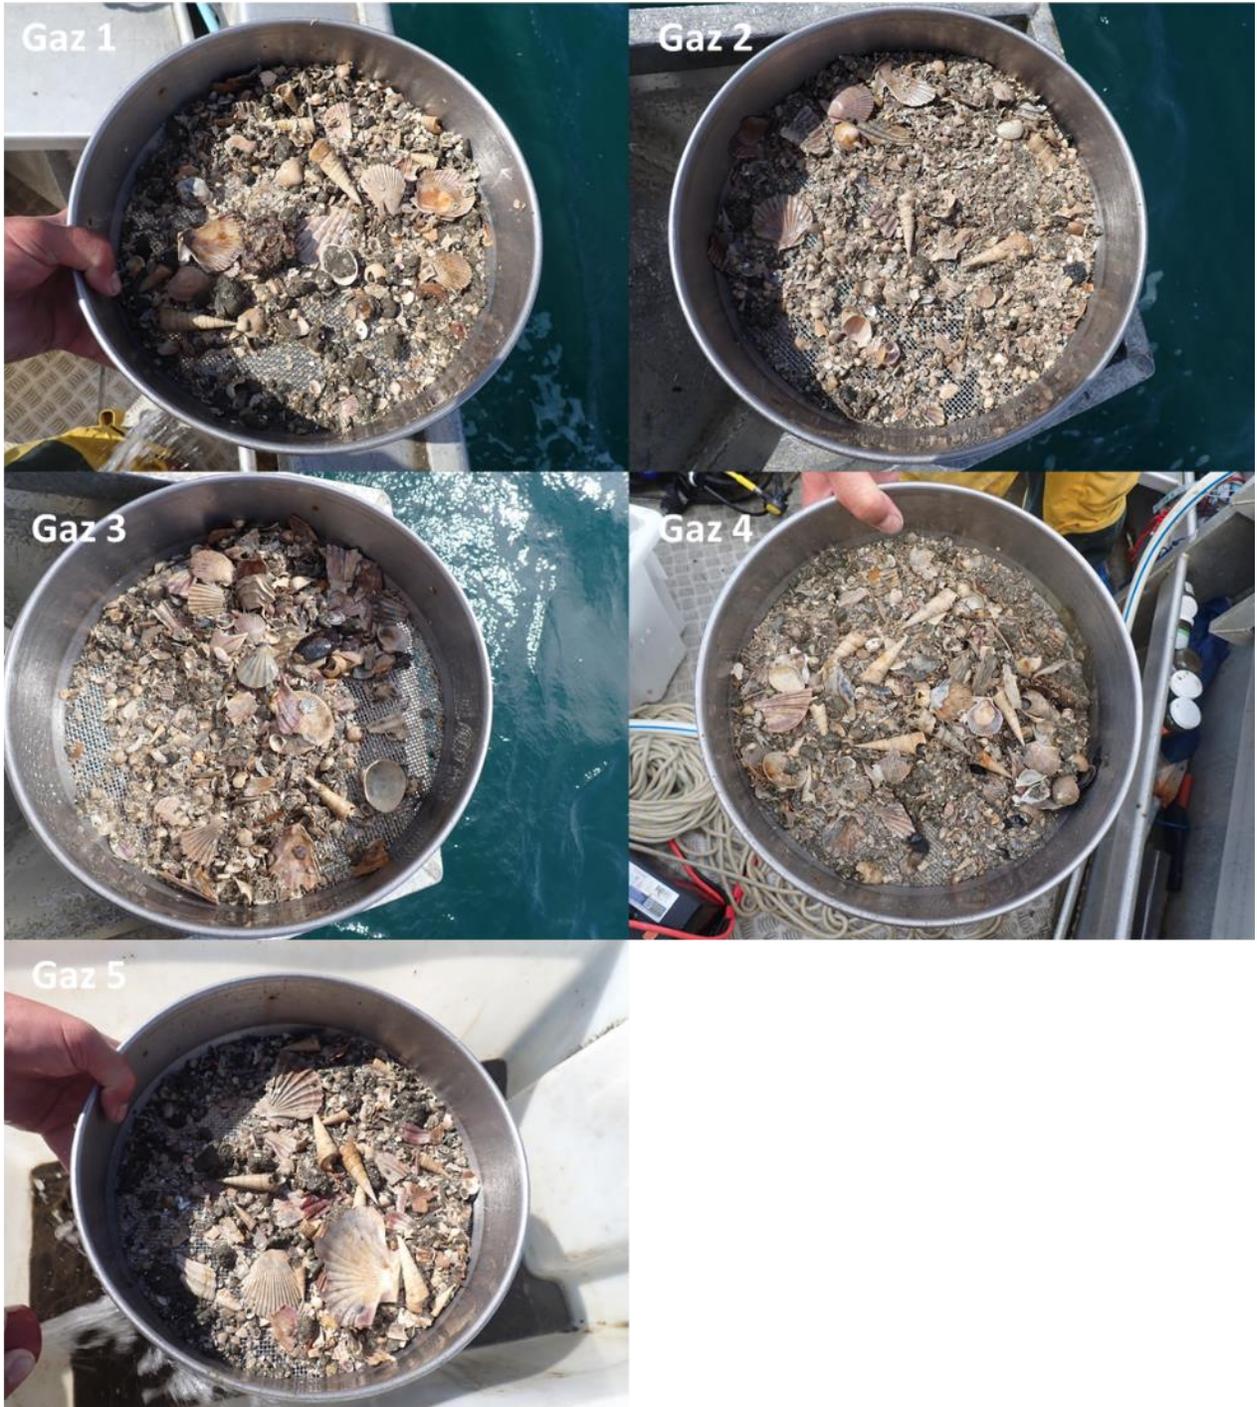
No *Gazameda gunnii* identified in any of the samples collected at Helliwells Point, Woodbridge (Figure 6). The grabs consisted mostly of shells, shell fragments and shell grit. These shell fragments were difficult to identify on a species-specific level due to their small size, however some fragments and whole individuals of the invasive New Zealand screwshell, *Maoricolpus roseus* were identified. There was a significant quantity of scallop shell debris also observed in all the samples, consistent with the observations made by divers in Section 6.2. Sample 1 also contained fragments of heart urchin (*Echinocardium cordatum*) (Figure 6).

Figure 6 Images of the sieves of *Gazameda gunnii* grabs at Helliwells point, Woodbridge.
