Geology & Resource Potential Assessment of Fishes Quarry, Interlaken Road, Southern Midlands

Report for Southern Midlands Council

**Ken Morrison M. Econ. Geol.
K. C. Morrison Pty Ltd**

16 November 2013

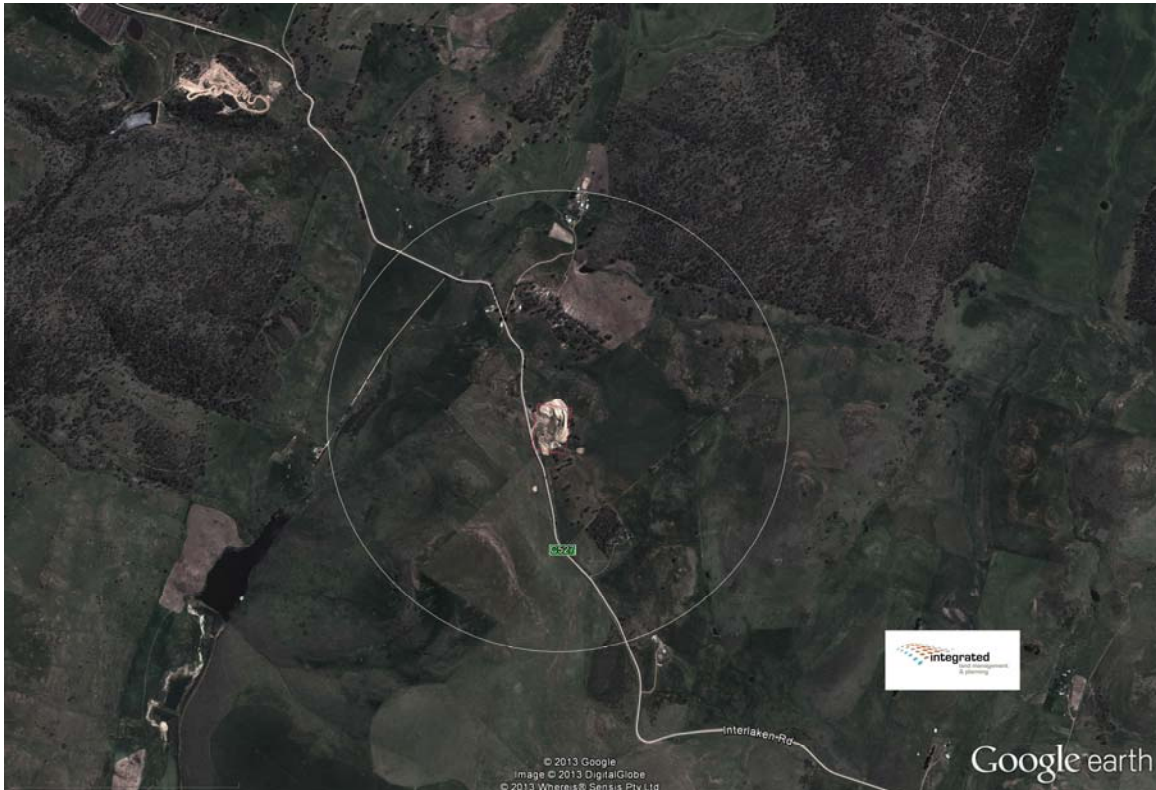
Figure 1. Location of Fishes Quarry, immediately east of Interlaken Road, approximately 5km northwest of Oatlands (image supplied by Integrated Land Management & Planning).

Southern Midlands Council operates a construction materials quarry located approximately 5km northwest of Oatlands and accessed from the eastern side of Interlaken Road (Figure 1). The quarry is on private grazing land and is covered by Mining Lease 1490P/M (3 hectares), which is current until 27/9/2017. The quarry has provided a range of road making and general construction materials since 1992 and is considered by Council to be an important asset, due largely to the diversity of crushed stone products facilitated by the somewhat unusual geological setting (see discussion of geology below).

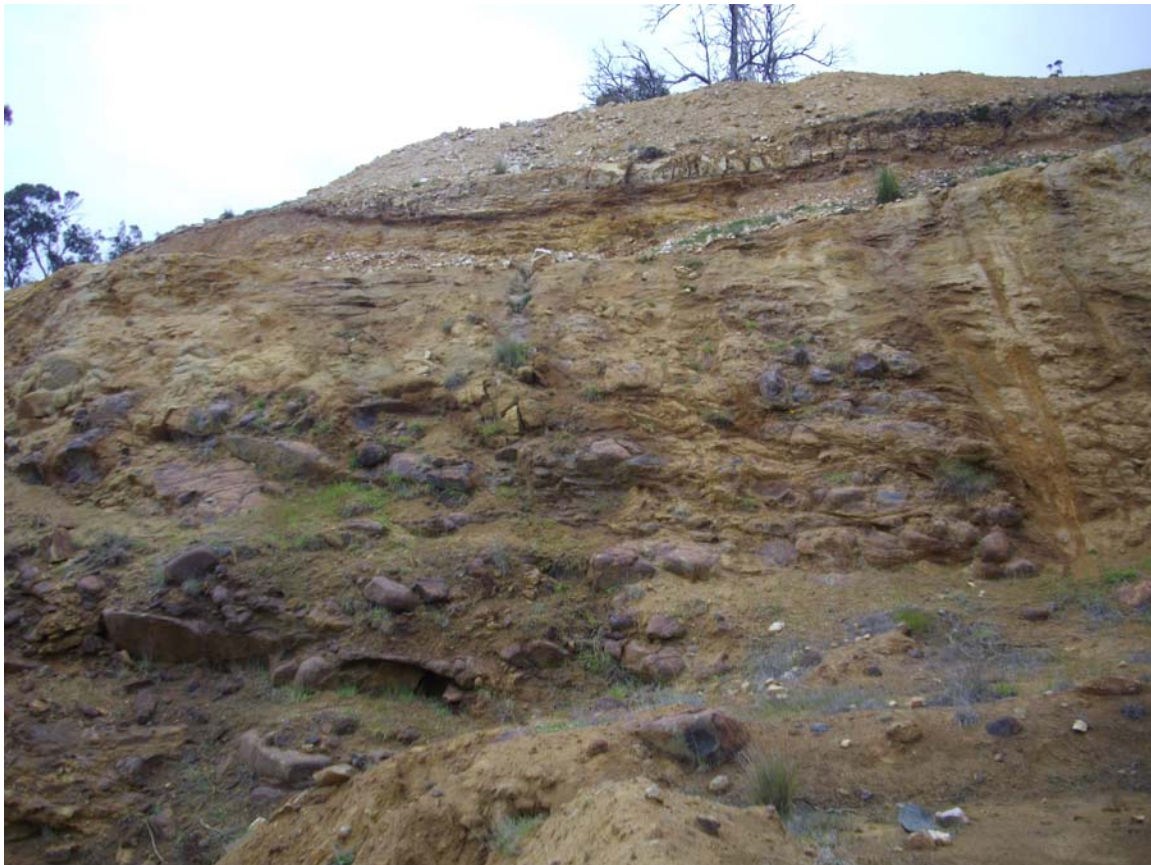
Figure 2. *Rounded boulder sized kernels of fresh hard dolerite embedded in weathered soft dolerite, overlain by silicified sandstone, southern end of the current quarry. Note the increasing proportion of fresh dolerite with depth (face approximately 6 metres high).*

The quarry is developed on a Jurassic dolerite sill with a thin overlying unit of Triassic quartz-clay sandstone and siltstone (Figure 2). The dolerite has intruded the sedimentary rocks as a hot magma and thermal alteration around the contact zone has resulted in bleached, hard, brittle, blocky siliceous hornfels within the sedimentary unit and fine grained blocky, brittle chilled margin dolerite. Both contact altered rock types extend for only a few metres either side of the contact and represent minor fractions of the exposed resource. Locally, deep weathering and oxidation has decomposed the contact rocks.

At the southern end of the quarry the dolerite-sandstone contact is near horizontal (with minor buckling deformation – Figure 2) but at the northern end the contact dips north at a shallow angle and transgresses the sandstone bedding slightly (Figure 3).

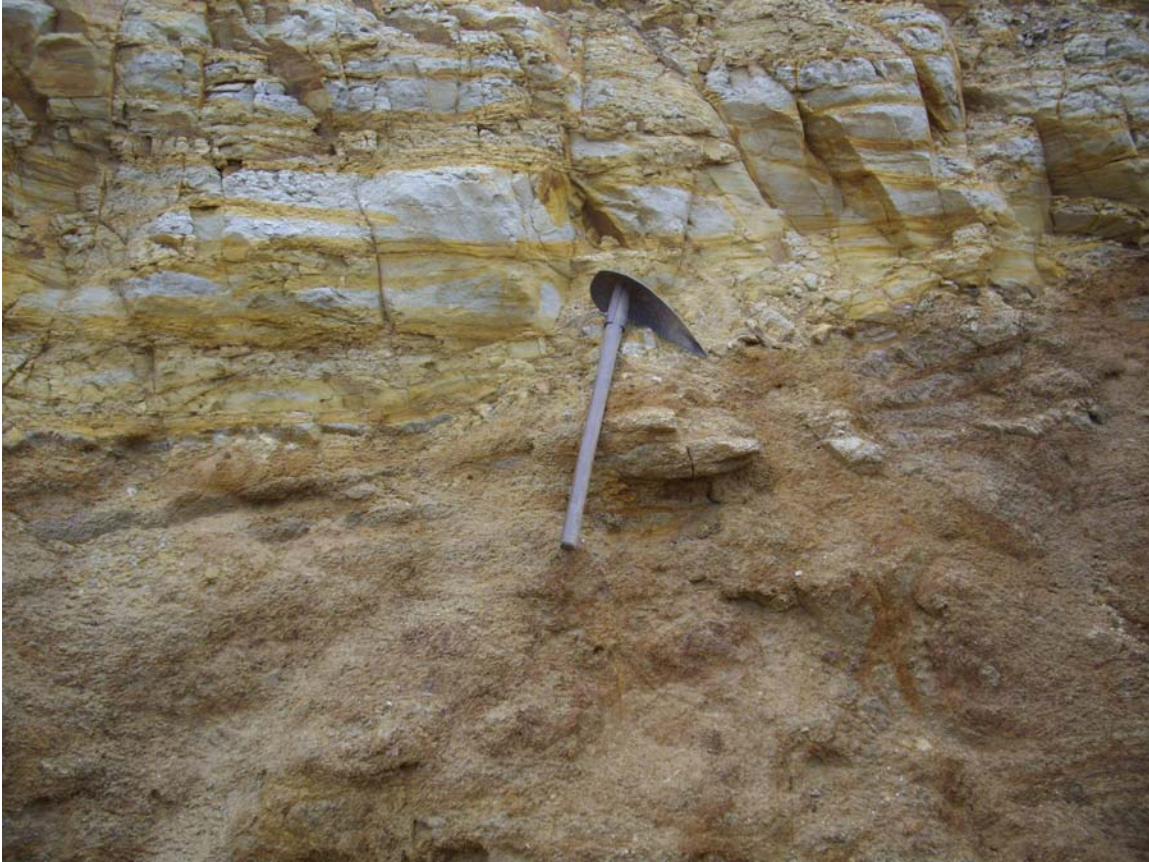
Figure 3. *Shallow north dipping contact between bleached, partly silicified flat lying sandstones, overlying deeply weathered oxidized dolerite, northern end of the quarry. This dolerite is an excellent source of brown gravel for road making but the sandstone is clay rich and unstable and is generally left for rehabilitation landscaping.*

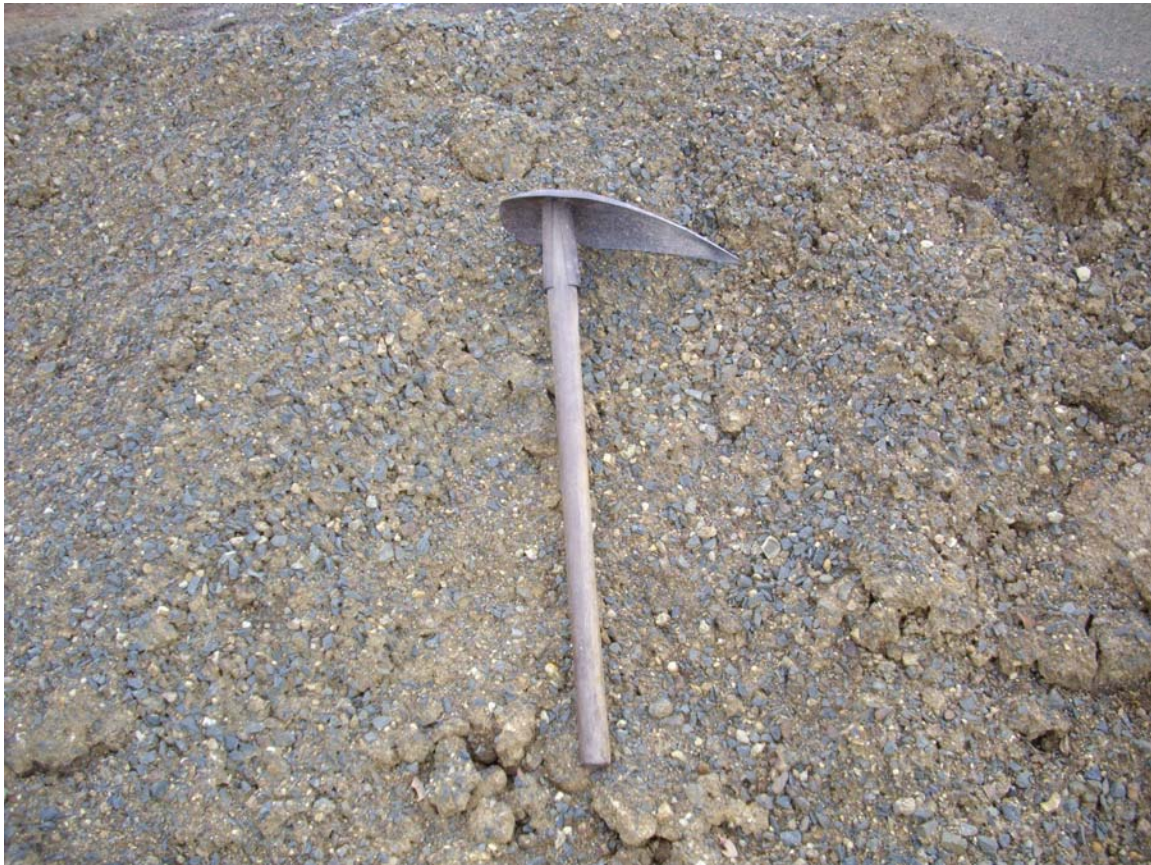
Figure 4. Aggregate for gravel road construction – approximately 70% deeply weathered dolerite and 30% fresh bluestone dolerite. Minor amounts of pale blocky hornfelsed sandstone can be tolerated.

- 1) Crushed stone brown gravel for gravel roads, blended to approximately 70% deeply weathered dolerite plus 30% fresh bluestone dolerite aggregate (Figure 4).

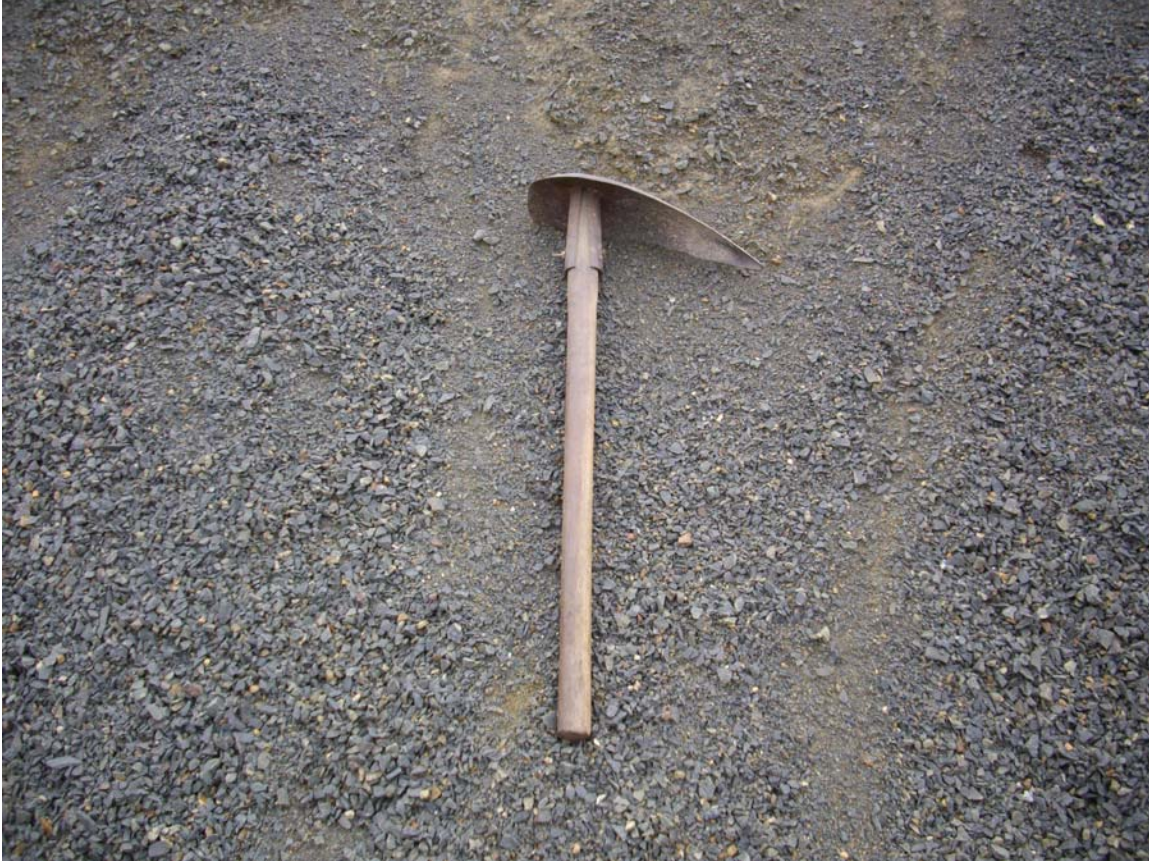
Figure 5. Aggregate for constructing the base of sealed roads – approximately 15% deeply weathered dolerite and 85% fresh bluestone dolerite. Almost none of the sedimentary rock can be tolerated.

- 2) Crushed bluestone aggregate for use as base material in sealed road construction, blended to approximately 85% fresh dolerite plus 15% deeply weathered dolerite (Figure 5).

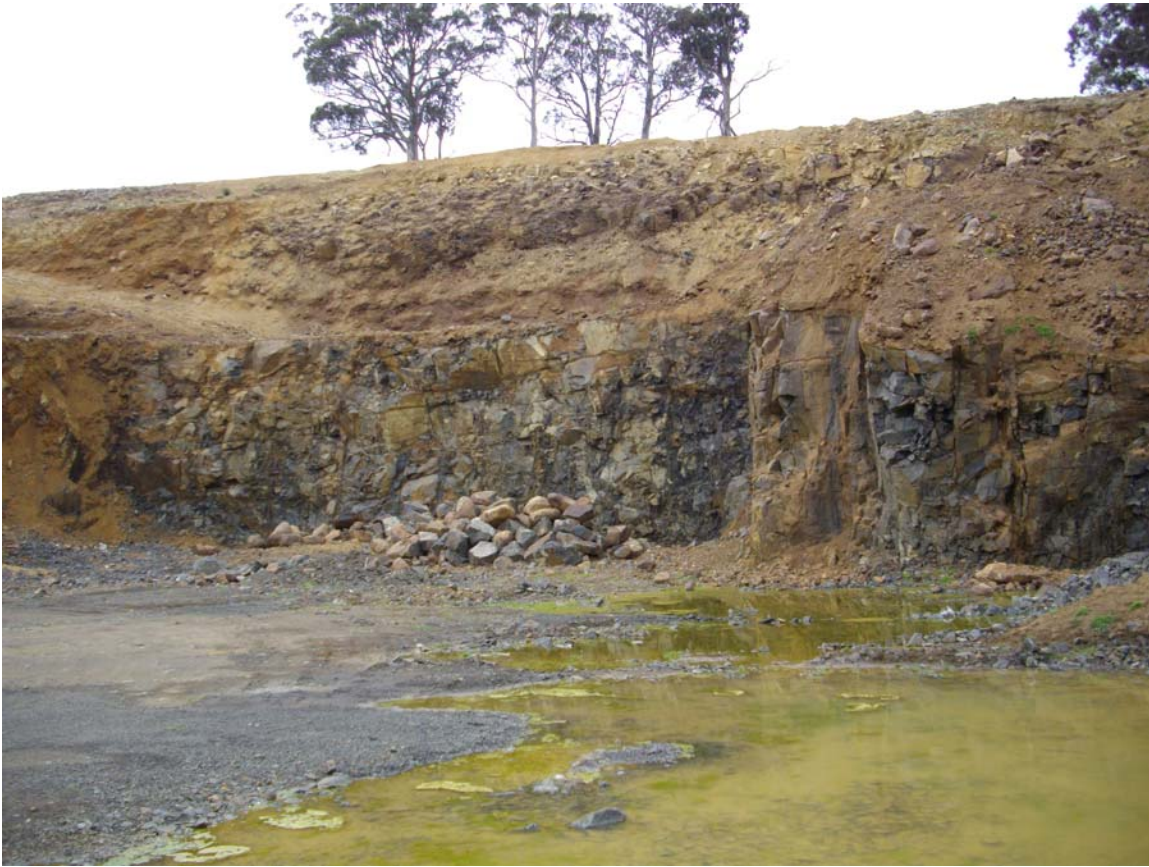
Figure 6. *Dolerite high wall in the centre of the current quarry. After pre stripping approximately 0.5m of soil and regolith, the proportions of fresh and weathered dolerite are ideal for current needs and the floor level allows for control of drainage entering the quarry from the southern (right) side. Additional resource potential appears best to the southeast, i.e. obliquely to the right.*

Considering both the optimum mix of materials needed and the current rock exposure in the quarry face, the best potential for demonstrating additional resource to support an expanded operation, is to develop in a southeasterly direction from the dolerite high wall in the central part of the current quarry (Figure 6). Drilling ahead of the current face is required to confirm the resource.

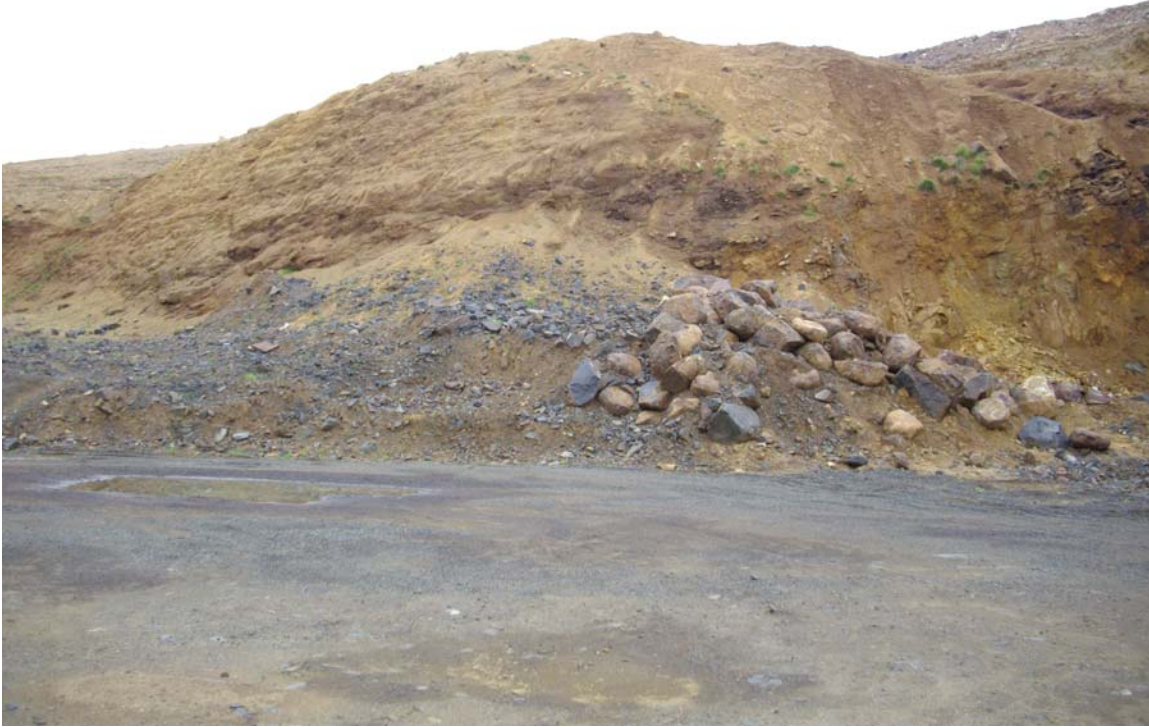
Figure 7. Northern end of the quarry, showing good quality weathered and fresh dolerite to the right, grading to increasing waste due to deeply weathered high clay dolerite and sandstone to the left (north) of photo.
